Behavioural assessment of clock towers subsequently added to historic structures

Assist.Prof. **Burcin S. Seker**, PhD. CE
Amasya University
Merzifon Vocational School
Amasya, Turkey
senol.seker@amasya.edu.tr

Professional paper

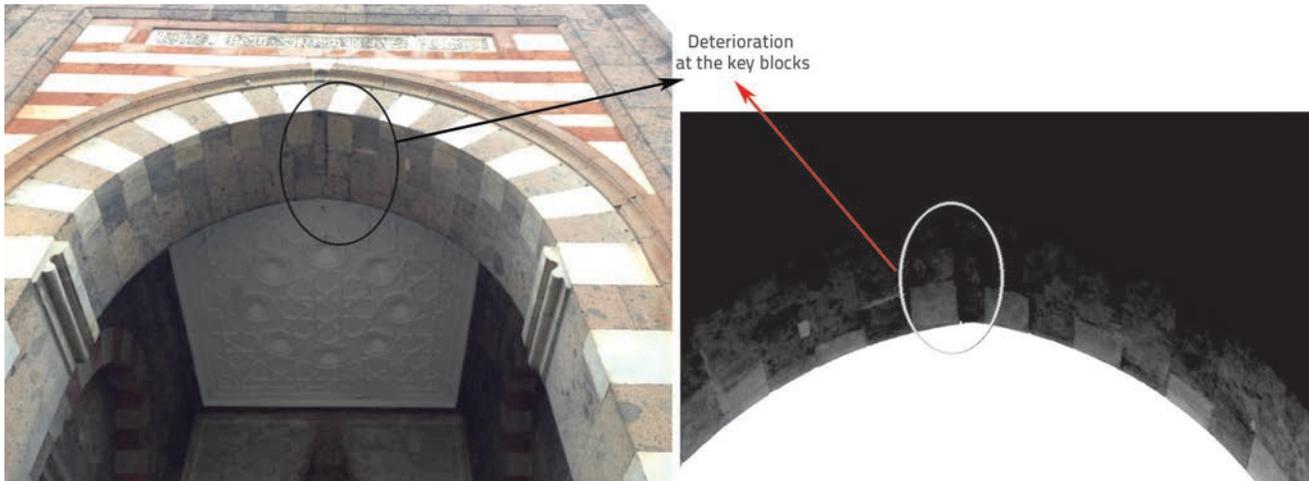
An in-situ investigation relying on visual analysis was carried out in this study in order to determine structural deformations of the towers. Visible signs of structural deterioration were visually examined in the light of structural features and architectural characteristics. Deteriorations observed in the towers were mainly concentrated in key blocks of main arches

(Figure 3). More specifically, several micro and macro cracks were detected on the upper parts of the lateral façades of Merzifon Clock Tower. Some significant micro and macro cracks were also discovered at external surfaces of the inside section of Gümüşhacıköy Clock Tower. These cracks are considered to be visual signs of structural deformations (Figure 4). In addition, flaking, powdering, swelling, dampness, and stains, were observed at the internal section of Gümüşhacıköy Clock Tower.

Figure 3. Deterioration at key blocks of Merzifon Clock Tower

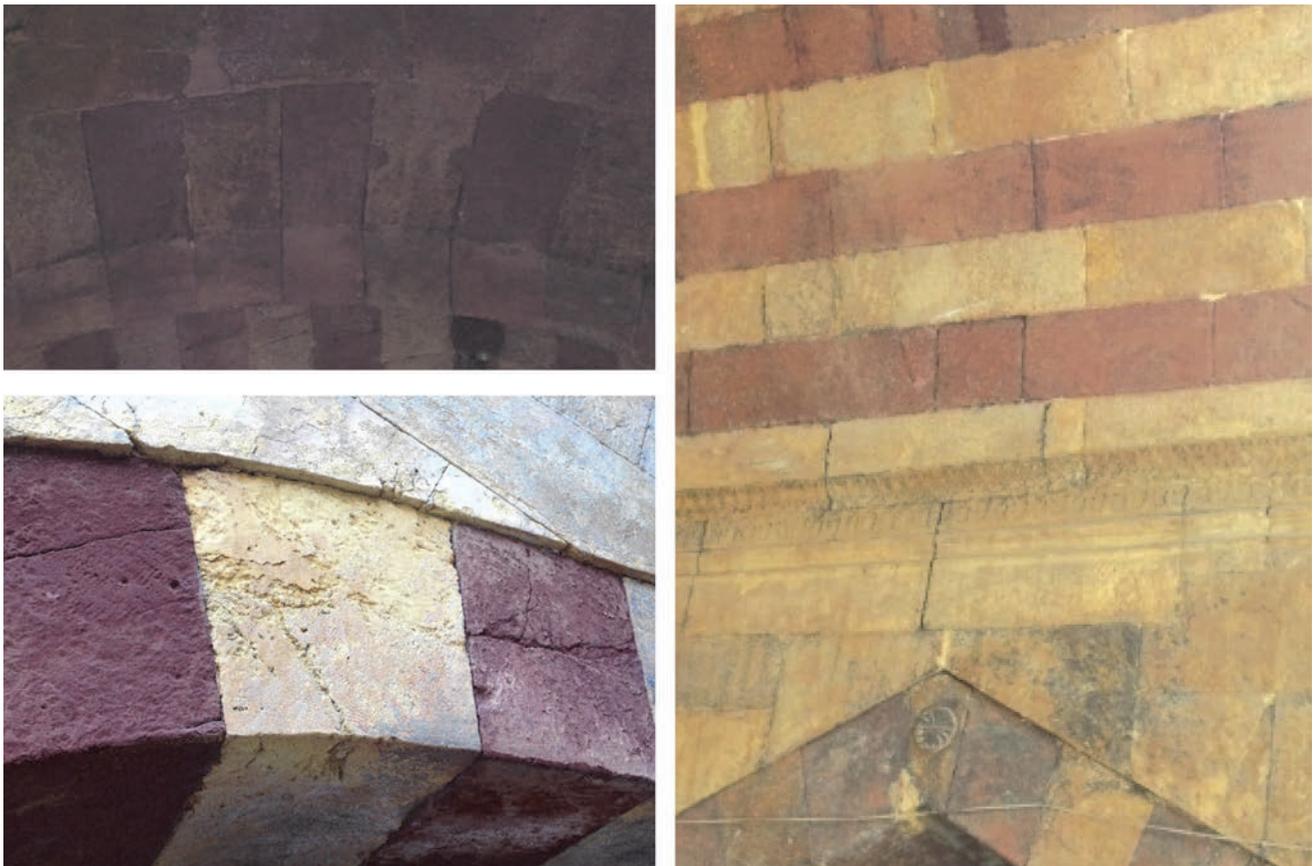
Figure 4. Some micro and macro cracks at Gümüşhacıköy Clock Tower

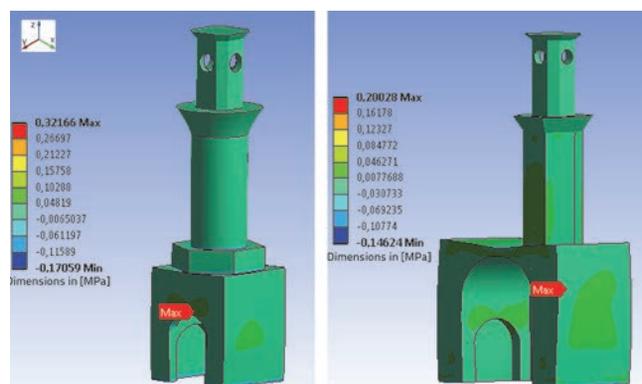
Static analyses were first performed on the finite element models to determine structural behaviour, i.e. to observe behaviour of these structures under their own weight. Comparative static analysis results are provided in the following figures. The static analysis indicates that maximum principal stresses amounts to about 0.32 MPa for Merzifon Clock Tower and 0.20 MPa for Gümüşhacıköy Clock Tower. It can be seen that the stresses occur at the top of the arches at the entrance and the skewback of the arches in the lateral façades as tension (Figure 7). Additionally, the maximum compression stresses were found to be about 0.92 MPa and 0.65 MPa for Merzifon Clock Tower and Gümüşhacıköy Clock Tower, respectively. The compression stresses are concentrated at the base sections (Figure 8). Furthermore, maximum vertical displacements occur at the top of the towers and amount to about 0.40 mm and 0.18 mm for Merzifon Clock Tower and Gümüşhacıköy Clock Tower, respectively (Figure 9).

Figure 7. Maximum principal stresses

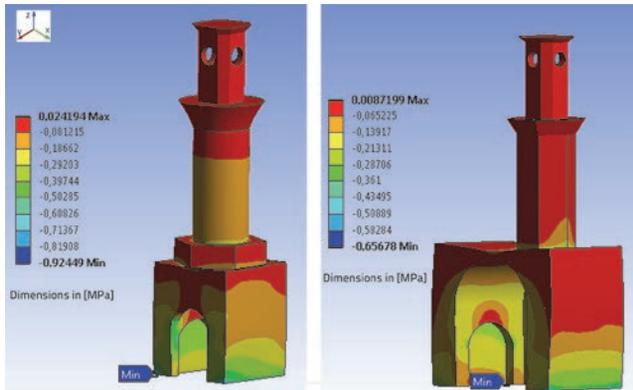
Figure 8. Minimum principal stresses (MPa)

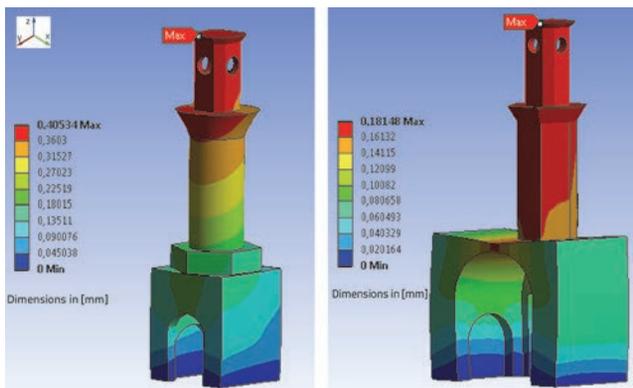
Figure 9. Maximum vertical displacement

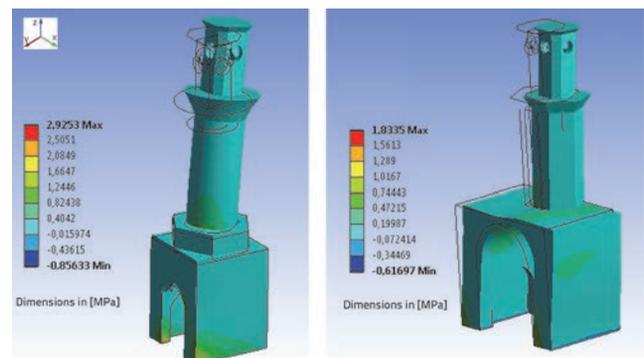
Figure 13. Maximum principal stresses for Kocaeli earthquake

tension at transition areas of these structures. This behaviour can especially be observed at the first mode of Gümüşhacıköy Clock Tower. Therefore, these areas may be expected to deform during an earthquake. Dynamic analysis results suggest that the principal stresses during an earthquake will be concentrated on the junction point of the base of the towers and the entrance gates, while the tower structure that is significantly higher compared to the underlying structure may not keep up with the shift and collapse. Furthermore, a comparison of the results for both towers indicates that Gümüşhacıköy Clock Tower made of wood has caused less damage to the underlying structure. Thus, if it is absolutely necessary to add a structure, then a less solid material should be preferred. The analysis results suggest that tension will increase on the base corner points of the entrance gates of the structures as a result of the shift movement during an earthquake, and that recurring earthquakes will adversely affect these bearing points. Regardless of their purpose, structures subsequently added onto the existing ones are believed to cause serious damages to the existing structures.

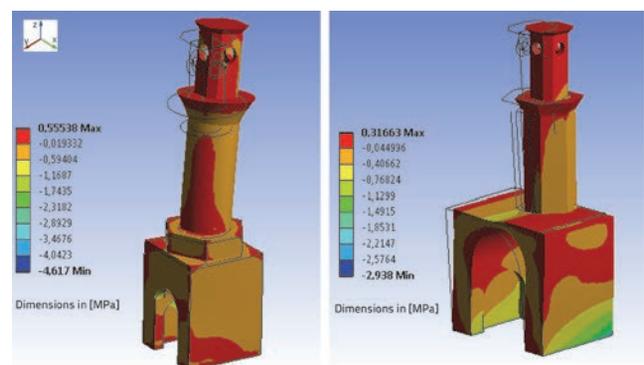
Figure 14. Minimum principal stresses for Kocaeli earthquake

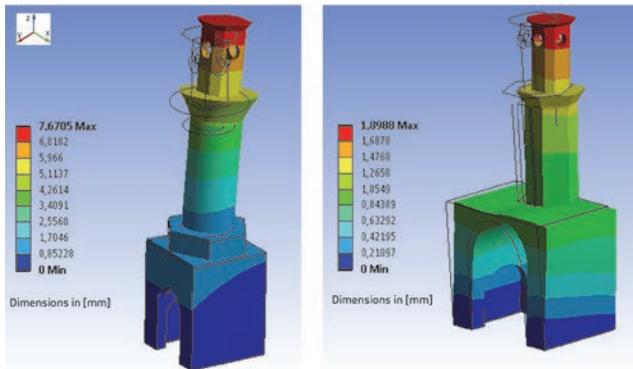
Figure 15. Maximum lateral displacements for Kocaeli earthquake
