Inspection and condition assessment of existing timber structures

Subject review

4. Case study – Technical museum Nikola Tesla, Zagreb, Croatia

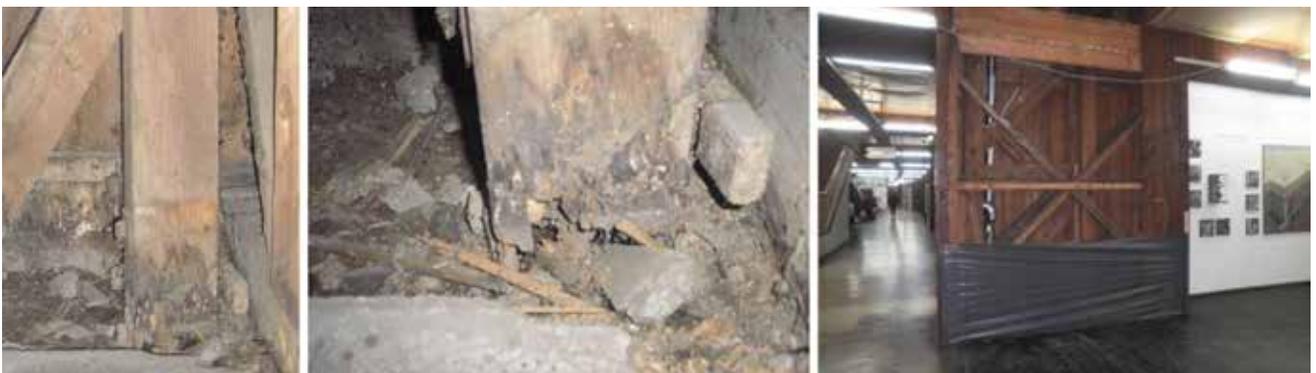
façade column assemblies, and central frame column assemblies in foundation details (Figure 9). At the western part of the façade, timber columns were in direct contact with concrete foundations, and decay was caused by a blocked drainage system that caused continuous pouring of water and/or a direct contact with water and/or soil [18]. Preliminary investigation work also revealed damage to many columns at the west and east façades, both with central frame columns (especially the ones oriented toward east). They were in direct contact with the ground and/or

water because of poor drainage, which caused decay in the lower part of the columns [18].

Figure 9. Severe damage to central frame columns

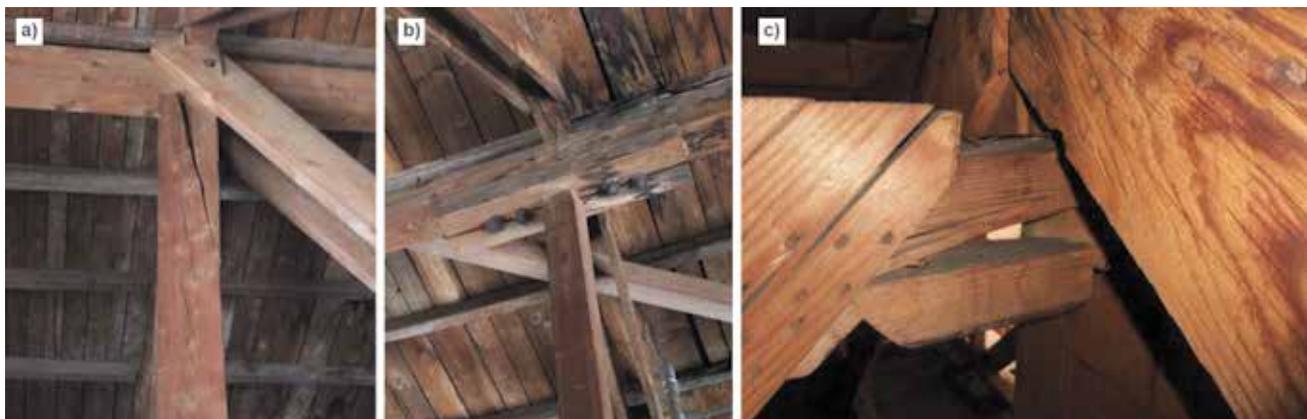
Figure 11. a) Longitudinal crack in column due to excessive load, b) cracks in timber element as a result of shrinkage and swelling, c) detail with questionable load-bearing capacity due to improper concept or missing fasteners

The last part of the assessment of the timber structure was a detailed survey of timber joints and connections between elements. Lot of connections in the structure were either poorly executed or their properties have deteriorated over time (Figure 11). A number of joints were executed with improper installation of fasteners, and so their load bearing capacity is questionable [18]. Carpentry joints were generally in good condition but some were not performing in the way

in which they were intended to. The main reasons for such situation are the changes that have occurred over time and/or initial improper realisation of timber joints.

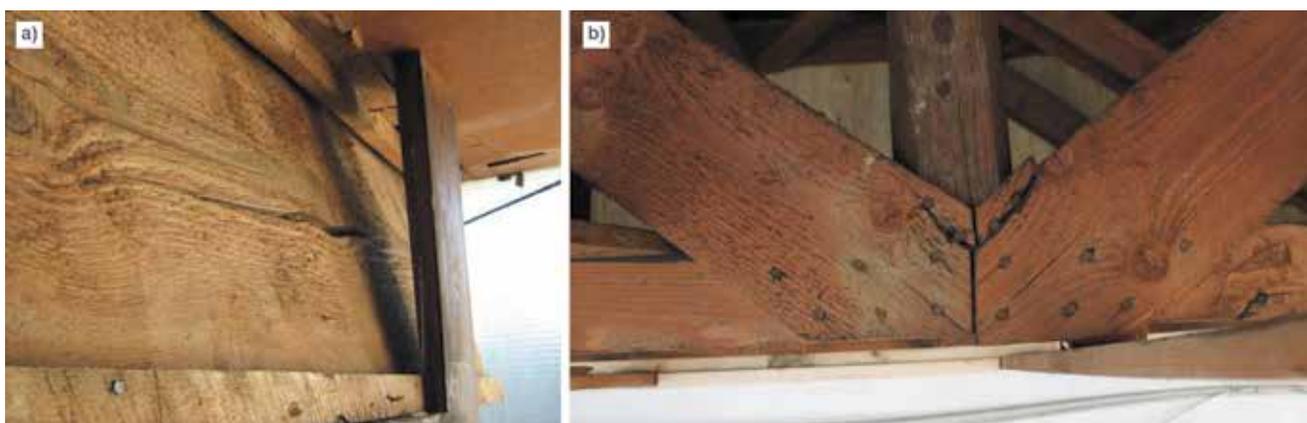
Figure 12. a) Torsional rotation of the beam, b) Improper installation of nails

A lot of other faults were observed in the structure, such as the poor fitting of timber members in joints, insufficient number of fasteners or insufficient spacing of fasteners, eccentricity in the joints, corrosion of some connectors, crushing of timber and biological attack (especially at the ground level), etc.

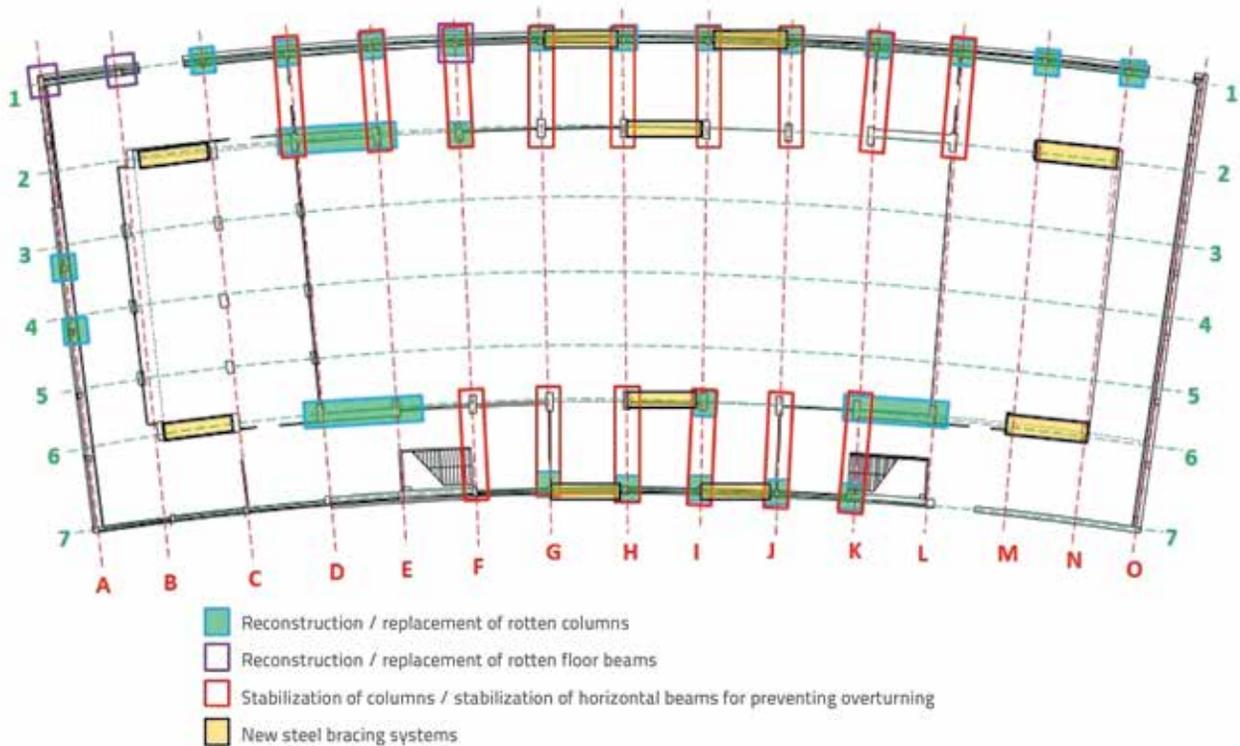
Figure 13. Reconstruction works at the ground floor of the museum

outlined. Principal reconstruction works and replacement of rotten parts at the ground floor are briefly presented in Figure 13. Principal reconstruction works and replacement of inadequate parts at the main roof timber truss are briefly shown in Figure 14.

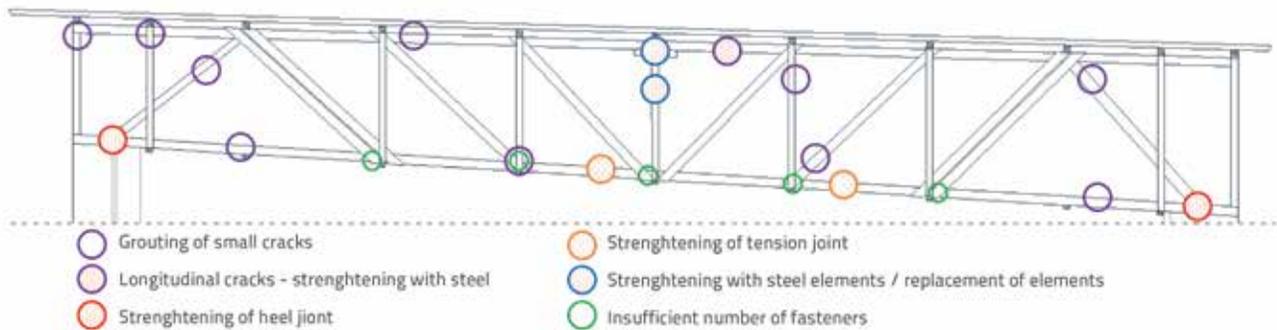
Figure 14. Reconstruction works at the main roof truss of the Museum
