Structural renovation of residential building in Zagreb after the 22 March 2020 earthquake

Professional paper

Juraj Pojatina, Dunja Barić, David Anđić, Dubravka Bjegović

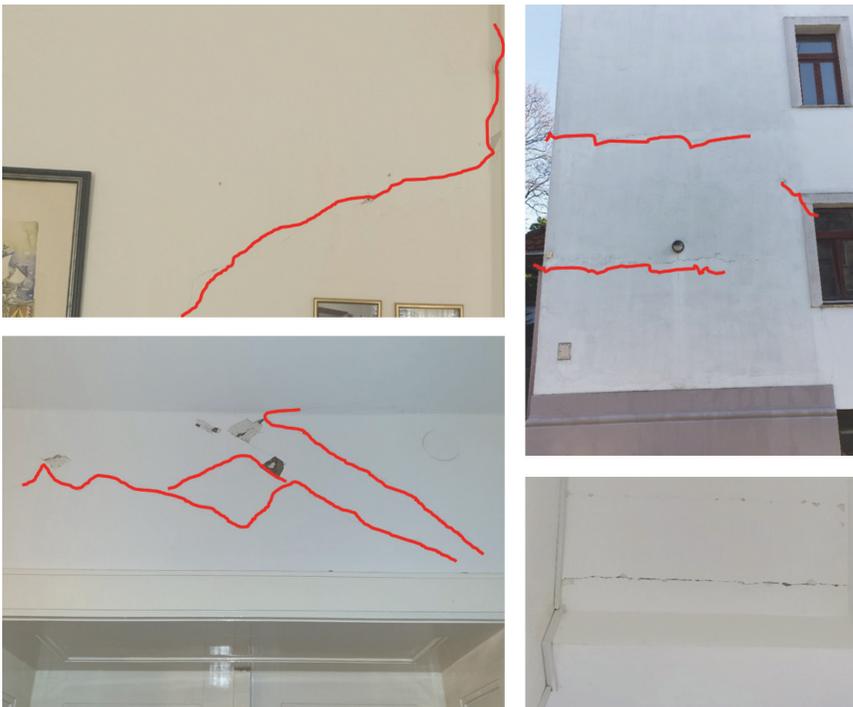
detailed inspection included inspection of all load bearing walls, inspection of ceilings and facades and inspection of all other non-structural elements of the building. Photographic documentation of the inspected building was also made, where all damage observed during inspections was properly marked. Geometry of all building elements was measured as basis for making drawings of the existing structure ??.. After the detailed inspection it was established that, although h the green lable was initially assigned to the building, the building did summer significant damage that was observed only after smaller investigations works such as those involving removal of plaster from some parts of the building, removal of some parts of the ceiling, etc. Some cases of typical damage are shown in Figure 4. Diagonal cracks at the load bearing ball, which transforms into a vertical crack at the connection with a partition wall, can be seen in Figure 4 (top left). Diagonal cracks

Figure 4. Typical damage to load bearing structure

at the lintel of the central load bearing wall can be seen in the same figure (bottom left). Cracks at the north facade are visible at the top right portion of the figure, while cracks at the staircase ceiling can be observed at the bottom right part of the figure.

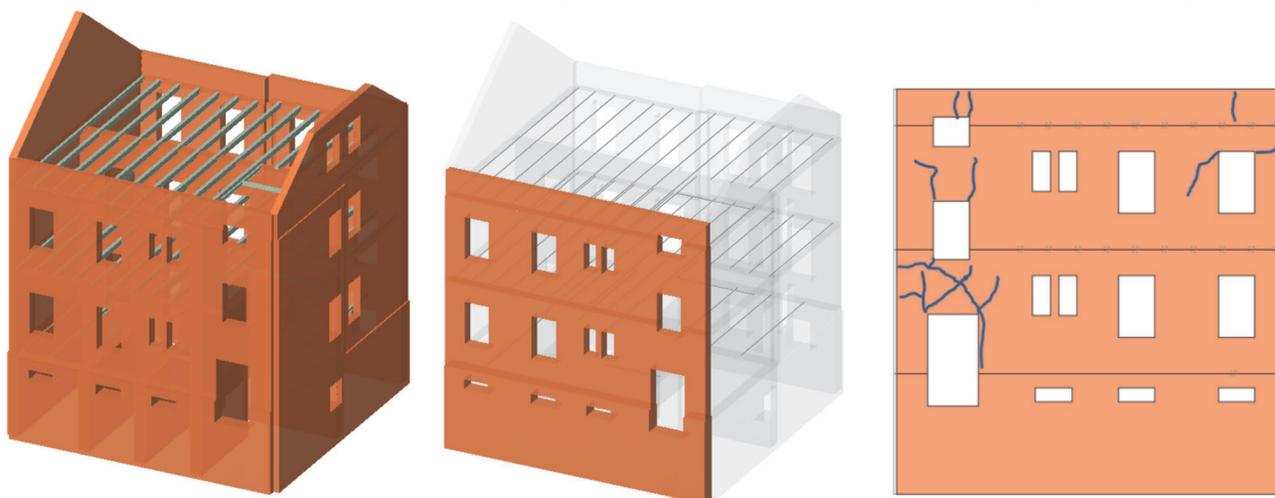
Figure 5. 3D model (left), typical east facade wall (centre), and damage marked at east facade wall (right)

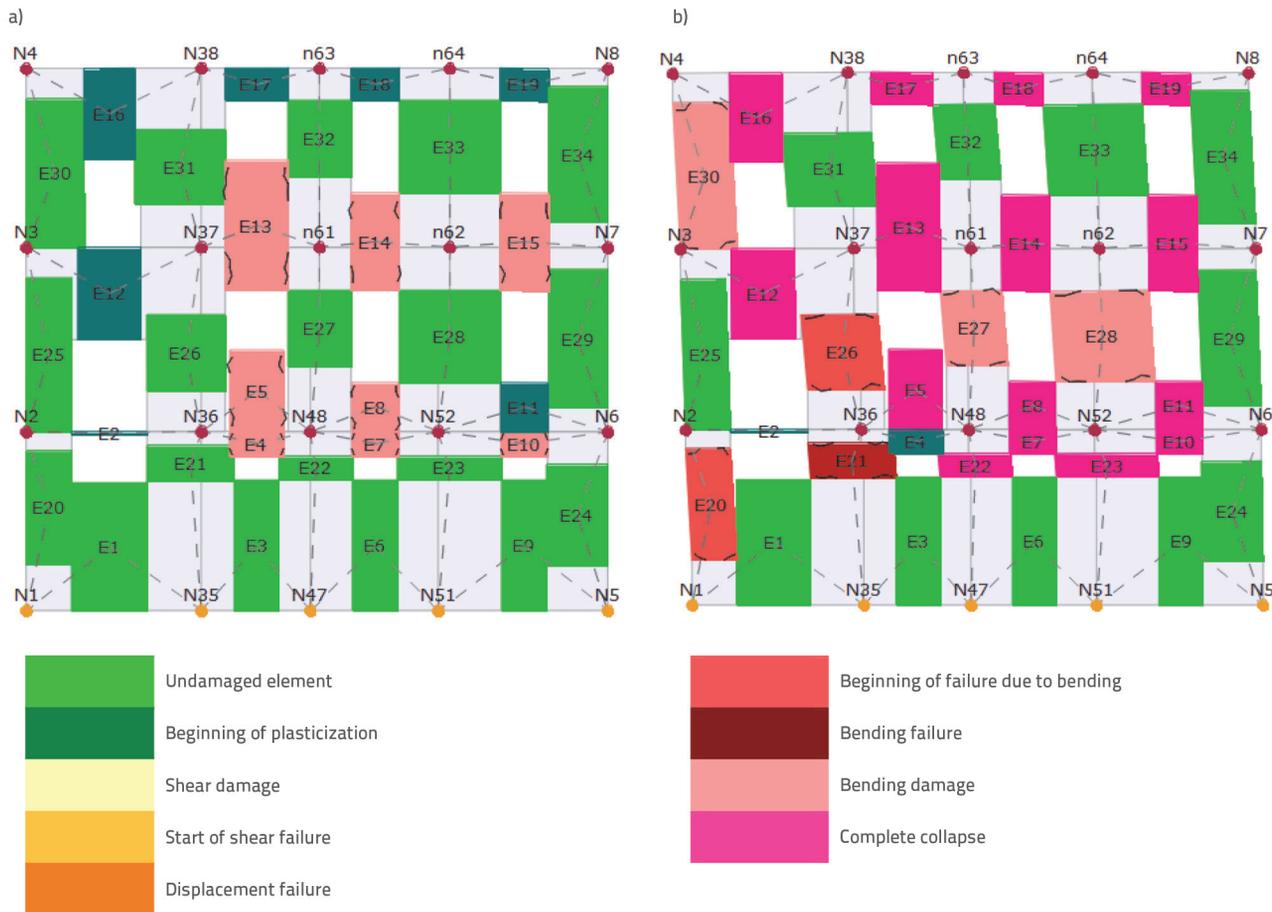
Figure 14a shows a typical wall and development of damage in that wall with the advancement of the analysis. Damage due to bending occurs at some horizontal elements already at initial steps of application of lateral forces. As damage to these elements can be considered acceptable, the analysis continues until failure of the global system.

Figure 14. Development of damage in typical wall in the Analysis No. 15: a) at the start of the analysis; b) at the end of the analysis

Figure 14b shows the end of the analysis No. 15. It can be observed that most horizontal elements (spandrels) have failed or are damaged due to bending. A number of vertical elements (piers) have suffered damage due to bending (E30, E27, E28), walls E26 and E20 are about to fail due to bending, while walls E21, E22 and E23 have already failed due to bending. Wall failure is manifested in Figure 14b as a sudden drop of capacity curve.

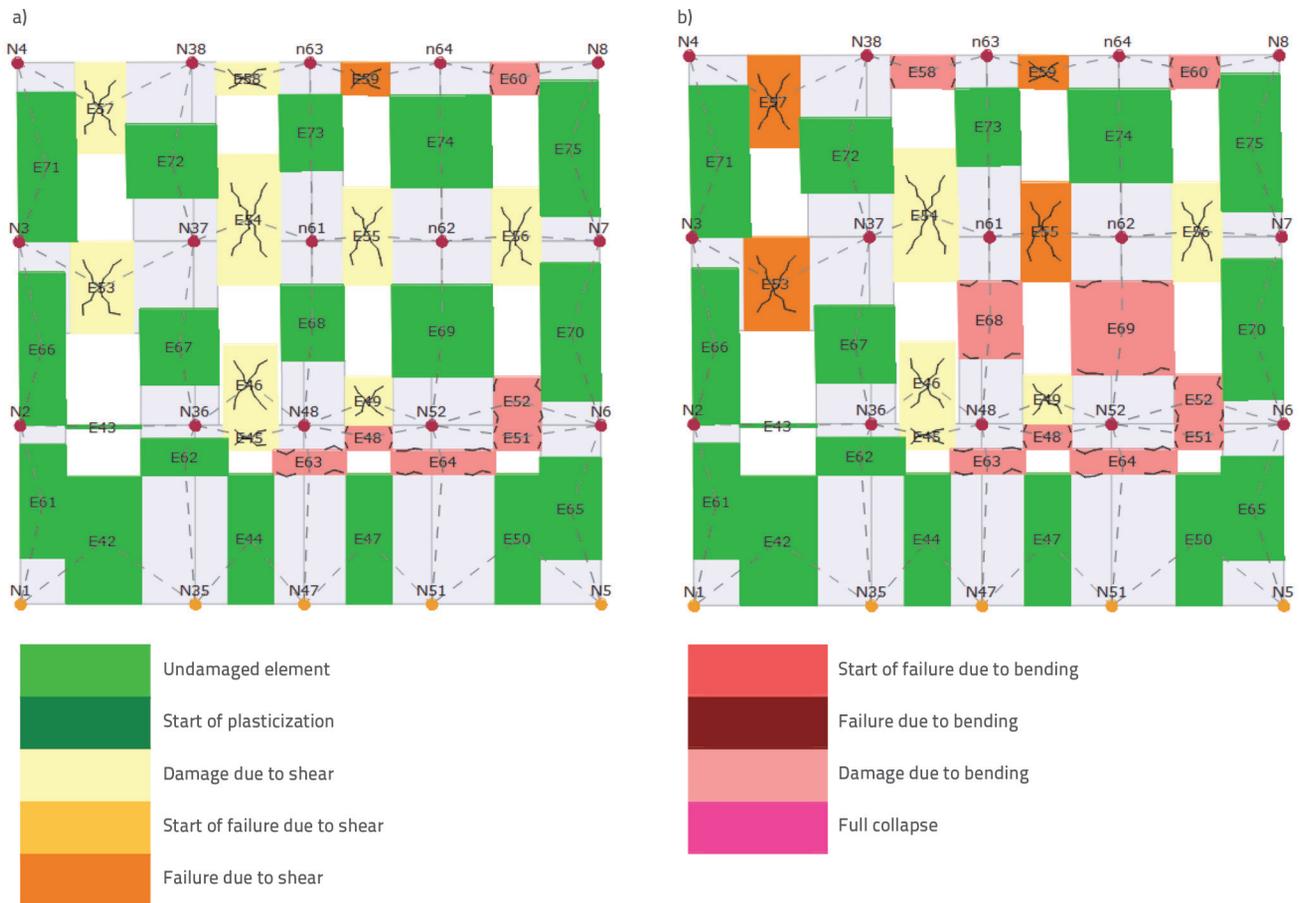
Figure 17a shows a typical wall and development of damage in that wall with the advancement of calculation. The first shear failure of horizontal elements (spandrels E59 – lintel above the first floor windows) occurs at the displacement of 1.86 cm. In addition, damage due to bending and shear also occurs at parapets and lintels of lower storeys. Vertical elements (piers) have not as yet started to fail, but they do exhibit some damage due to bending (E63 and E64).

Wall condition after the analysis No. 16 is shown in Figure 17b. It can be seen in that figure that no vertical element failed in the observed wall at the displacement of 2.53 cm, but that some of them suffered bending damage (E63, E64, E68 and E69). As to horizontal elements, some lintels and parapets at higher storeys failed, but most of other elements suffered damage due to bending and displacement. Considering that no global collapse occurred at the observed wall, the drop in capacity curve of the building is due to failure of an element in another wall.

Figure 17. Development of damage in typical wall in the Analysis No. 16: a) at the start of calculation, b) at the end of calculation
