# Comprehensive analysis of the damages in Hatay due to the February 2023 Pazarcık and Elbistan earthquakes

Professional paper

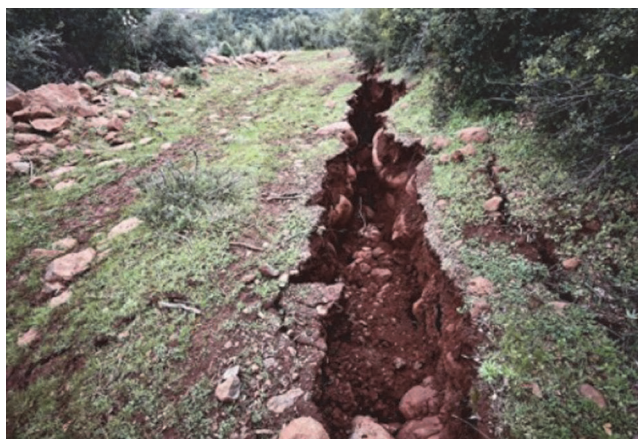
Analysing focal mechanism solutions revealed that these earthquakes struck left-lateral strike-slip faults following the characteristics of the EAFZ. Some of these analyses showed normal and reverse fault mechanisms due to local changes in fault geometry along the fracture line [1, 4]. Surface fractures were reported on the Pazarcık, Amanos, Erkenek, Türkoğlu, and Narlı parts of the EAFZ in the 06 February 2023 Pazarcık earthquake (7.7 Mw). The Amanos Fault (Figure 1, rectangular box 2) extends toward Hatay, with separate ruptures observed through Türkoğlu, toward Hassa and Kırıkhan [2]. This fault, which stretches from the south of Türkoğlu to Antakya, is reported to have ruptured because of the first Pazarcık earthquake. Along the surface fracture of the Narlı segment, including parts of Hatay, left-lateral displacements ranging from 10–700 cm were observed. Left-lateral strike-slip surface fractures occurred 19 km from the Serinyol segment and a 122.5 km stretch from the Amanos segment. The Çardak Fault extending from Nurhak east to Göksun and the Doğanşehir Fault in the Doğanşehir district of Malatya were observed to have ruptured in the region between the Göksun district of Kahramanmaraş and the Doğanşehir district of Malatya (indicated by box 1 in Figure 1) during the second earthquake (7.6 Mw) [2]. The left lateral displacements in this region ranged from 25 to 880 cm [9]. Surface ruptures and translational movement traces have been extensively observed in Hatay since the earthquake in February 2023. These ruptures caused height differences ranging from 1 m–3 m. Figure 3 shows the surface fractures and deformations [10].

Figure 3. Surface fractures in agricultural land and forested areas after the earthquakes in Hatay [10]

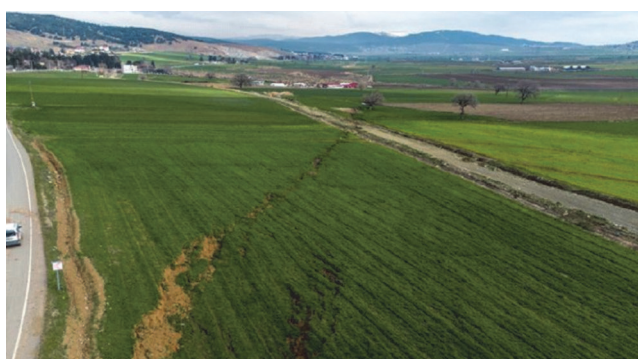
Large cracks occurred in the fields of Tepehan village oin the Altınözü district of Hatay owing to seismic activity (Figure 4). Ruptures with left lateral displacement split the land, causing 300 cm displacements. Additionally, as shown in Figure 5, deep pits of approximately 30 m deep and 200 m wide formed a 35-decare olive orchard in Altınözü [11, 12].

Figure 4. Large surface fractures in agricultural land after the earthquake in Altınözü [11,12]

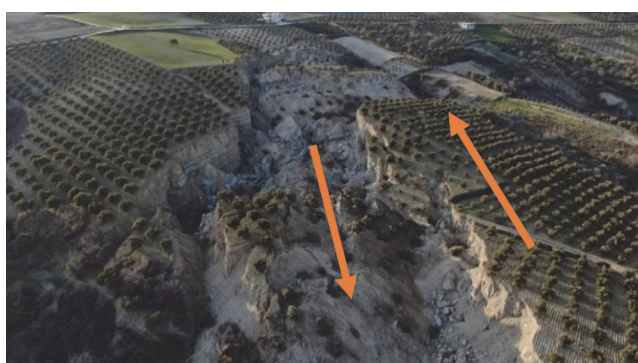
Figure 5. Deep pits in olive groves after earthquakes in Hatay–Altınözü district [7]

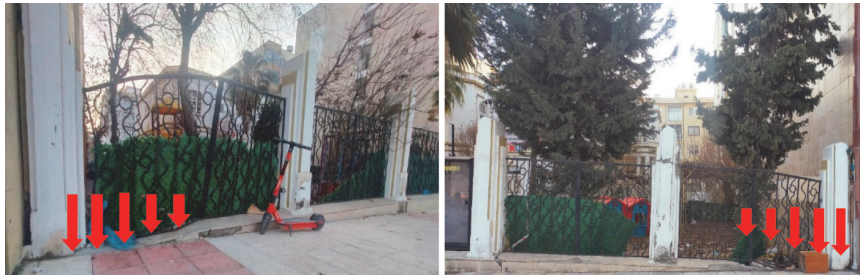
Figure 8. Liquefaction and sand slides observed in İskenderun–Hatay due to earthquake

Severe tremors have caused various problems in soil and foundation engineering in Hatay, including liquefaction, lateral spreading, sand boils, settlements, collapse/heaving, and differential settlements [26–30]. Cracks and crevices were observed in areas affected by sand boils. Evidence of liquefaction and sand boils was documented near Atakaş Mosque following the February 2023 earthquakes, particularly in the coastal region of Iskenderun (Figure 8). Figure 9 shows the cracks and wide splits on the highways.

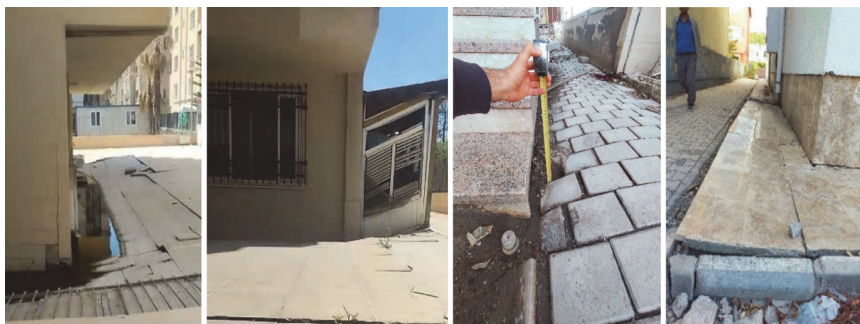
Figure 11. Approximately 60 cm subsidence and some settlements detected in Iskenderun after the earthquake

Although collapses and settlements of up to 80 cm were observed in structures along the coastal areas of İskenderun for a span of approximately 6 km after the earthquakes, complete collapse/demolition did not occur [31, 32]. Cases where soil liquefaction does not transmit high acceleration values (1.2 to 1.3 g) to structures are rare and warrant further investigation. Many coastal buildings are old, constructed on very soft or poor soils, and lack deep foundations such as pile-based slab foundations. Although this initially appears counterintuitive, the high average shear wave velocity ( $V_s(30)$ ) decreased in loose sand during the earthquake and contributed to the survival of the buildings. The foundations of the buildings near the beach, located on the ground that liquefied owing to seismic movement, were damaged following a 50–60 cm settlement in Iskenderun–Hatay (Figure 11).

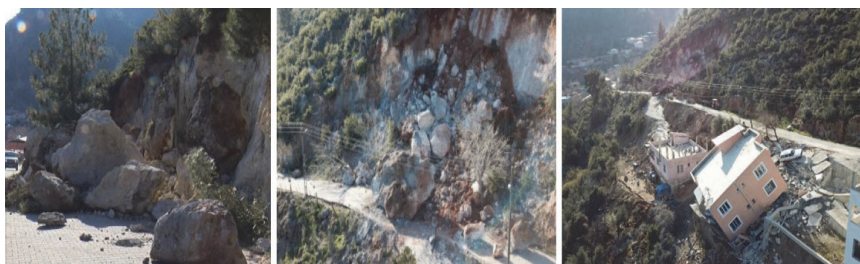
Figure 12. Landslides and rockfalls were triggered by earthquakes in Kırıkhan [34]

The dynamic movements caused by earthquakes can mobilise weak layers and large masses with the contribution of gravity [33]. The February 2023 earthquake triggered scarps, which caused landslides and landfalls. Rocks breaking off from the mountain fell on houses, and 49 people lost their lives in the village of Bektaşlı in the Kırıkhan district of Hatay (Figure 12).

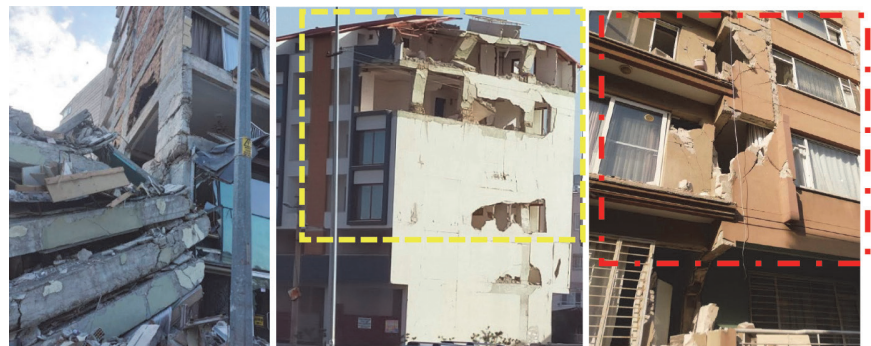
**Figure 13. Buildings whose structural elements were damaged by adjacent constructions**

damage; this is known as the hammering effect. Given Hatay's zoning status, contiguous construction is widespread, and many buildings have been damaged and collapsed from hammering (Figure 13). The elevation differences between buildings and different construction characteristics (year of construction, type of material, and quality) significantly cause damage.

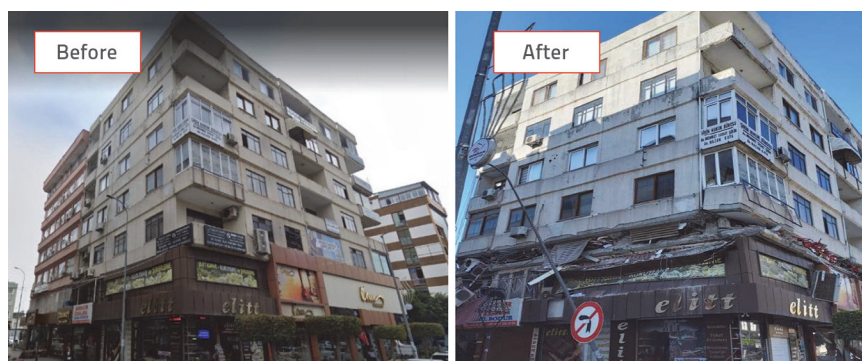
Soft-story effects refer to differences in rigidity between the floors of a building. According to TBEC-2018, type B2 is a vertical irregularity type. The regulation states that for two earthquake directions perpendicular to each other, if the ratio of the relative drift on any floor, except ground floors, divided by the ratio of the relative drift on the upper or lower floor is  $>2$ , soft floor irregularity is expected to occur. The columns in the mezzanine above the ground floor were crushed during the earthquake owing to the soft floor irregularity, and a building in Iskenderun was severely damaged (Figure 15).

Figure 15. Previous and post-earthquake damage to a building in Iskenderun–Hatay

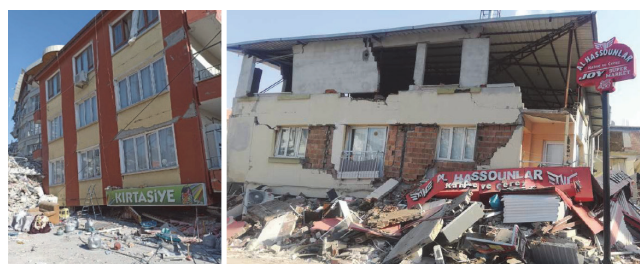
Figure 16. Soft-story buildings in Antakya–Hatay collapsed during the earthquake

In contrast to other floors, soft stories cause significant displacement. In this case, second-order effects, which are not considered in the design, occur on a soft floor, and the earthquake damage is felt more intensely on this floor. Accordingly, before the vertical load-bearing elements on the other upper floors reach half of their capacity under the earthquake effect, collapse and overturning can occur on the lower floors (Figure 16).

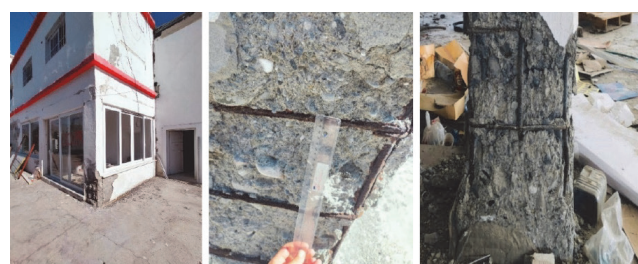
The damage investigation of a two-story building in Hatay Belen revealed that the column sections were inadequate ( $20\text{ cm} \times 20\text{ cm}$ ), concrete covers were inadequate, reinforcements were corroded, their diameters were thinned, stirrup hooks were produced at a  $90^\circ$  angle, and the stirrup spacing was 30 cm. Additionally, different diameters and numbers of flat reinforcements without ribs were used, and coarse aggregates were used in the concrete, which resulted in poor concrete quality (Figure 17).

Figure 17. Structural defects in a damaged multi-story building in Hatay after an earthquake

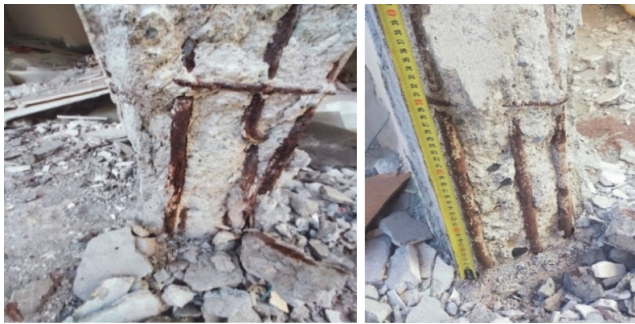
Corrosion-induced structural damage was high owing to the presence of seawater near Hatay, particularly in the coastal areas (Figure 18).

Figure 18. Loss of concrete reinforcement adherence and thinning of reinforcement diameter (cross-sectional loss)

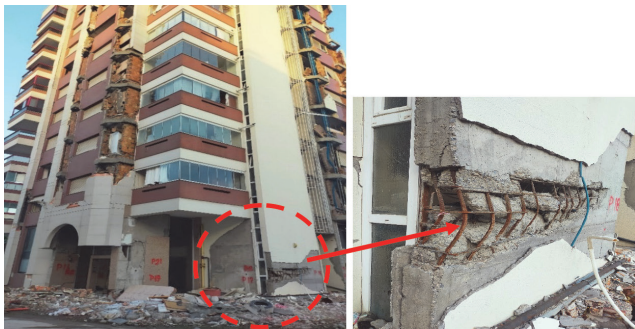
Shear and bending damage to shear walls in buildings that occurred during the Hatay earthquake on 6 February 2023 were examined. Damage occurred in the shear walls because of significant displacement and sectional stresses caused by severe shaking in a tall building in the Iskenderun district of Hatay (Figure 19). The concrete cover cracked, the concrete was shattered, exceeding its compressive capacity, the stirrups opened, the longitudinal reinforcements were shifted by 10 cm, and some longitudinal reinforcements and stirrups were broken.

Figure 19. Plastic deformation and out-of-plane bending damage in Iskenderun–Hatay shear wall

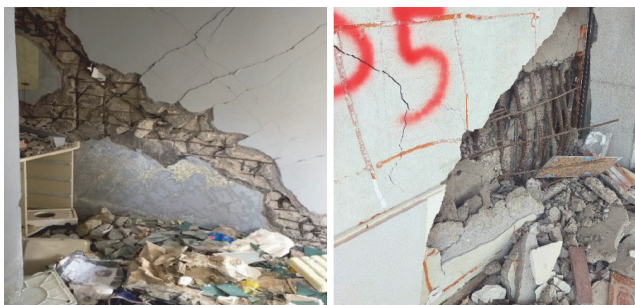
Figure 20. Diagonal cracks and loss of sections in structural walls

Diagonal cracks occurred in load-bearing shear elements in response to excessive cross-sectional pressures or insufficient cross-sectional dimensions (Figure 20).

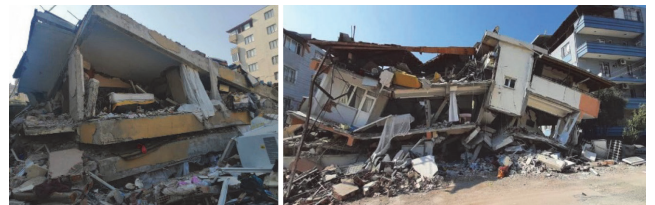
The TBEC-2007 [42] stipulates that columns must be stronger than beams and that the sum of the bearing moments of the columns joining each column-beam joint must be at least 20% greater than the sum of the bearing moments of the beams joining the joint on the column face in structural systems consisting of frames or a combination of shear walls and frames. Otherwise, the case is referred to as a weak column-strong beam irregularity (Figure 21). The endpoints of the columns were stressed beyond their maximum strength capacity, which caused brittle cracking, soft floor formation, and even total collapse.

Figure 21. Strong beam-weak column behaviour in Antakya and Iskenderun

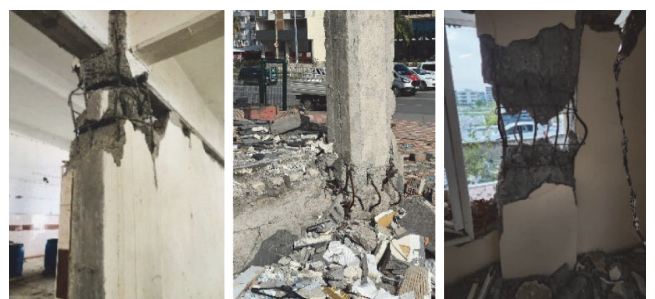
Poor workmanship contributes to damage caused by earthquakes. Some stirrups were not bonded to the longitudinal reinforcement in the carriers of collapsed or severely damaged buildings. The stirrups cannot provide sufficient adherence to the core concrete and open immediately because of the dynamic movement (Figure 22).

Figure 22. Inadequate transverse reinforcement

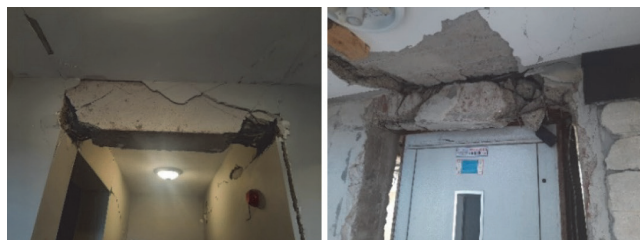
Beam damage was common in these earthquakes and was observed in short beams connected to shear or column elements. There was also significant damage to short beams connected to the elevator concrete wall and to short beams built to fulfil architectural requirements (Figure 23).

Figure 23. Examples of short-beam cracks connected to elevator shear walls

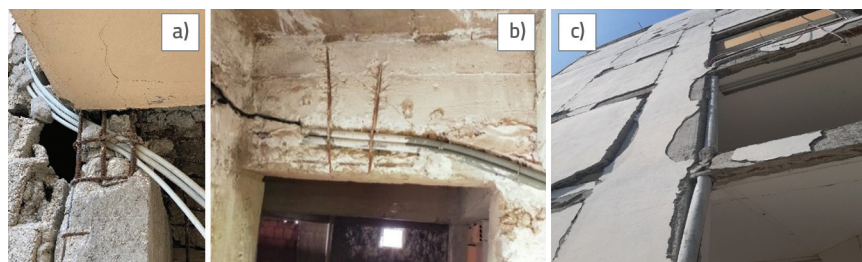
Irrelevant materials have also been found in the concrete when examining damaged buildings. Many systems, such as plumbing pipes and electrical cables, pass through structural elements, reducing the cross-sections of that element and thus the strength, causing more damage to the structure. As shown in Figure 24-a and b, electrical cables passing through the carrier reduced the strength of that section, and in Figure 24-c, plumbing pipes passing through the carrier reduced the cross-section in that area of the section, causing cracks to occur during the earthquake.

Figure 24. Materials that cause section losses in structural elements
