Analysis of cracking on running surface of rails

Professional paper

The problem of cracking at the rolling surface of rails is considered in the paper. This damage to the rolling surface of rails, known as "squat", may lead to disintegration of rail head in the length of 1 m or more. In the scope of this research, a detailed visual control of rail damage at the Vrbnica – Bar Section of the Montenegrin railway network was conducted in order to alleviate danger of rolling contact fatigue cracking in rails. Results obtained can be used as basis for preparation of technical regulations for railway track maintenance along the Montenegrin railway network.

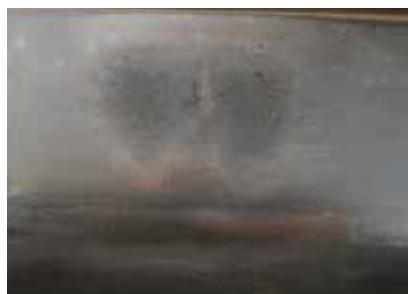
In this research of squat defects on Montenegrin railways, the basic definition of squat (rail defect type 227), as given in [4], is used: squats are visible on the running surface of the rail head as a widening and a localised depression of the rail/wheel contact band, followed by a dark spot containing cracks with a circular V-shaped arc, but in any case the main characteristic is the shape in form of two "lungs" [9, 10]. (Figure 1). Over time, the cracks propagate inside the rail head. At first, they propagate inside the head at a shallow angle to the surface (max. 20 to 30 degrees from the horizontal). Then, when they reach 3 to 5 mm in depth, they propagate downward transversely and may cause rail failure. Generally, the shape of the fracture surface due to

Figure 1. Typical defect in form of "lungs", Vrbnica – Bar Railway, Podgorica – Golubovci Section

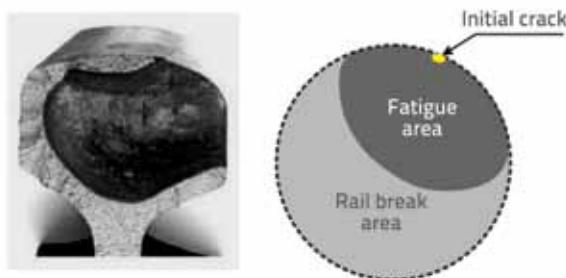
the rolling contact fatigue is quite characteristic. Two visually different surfaces can be distinguished: fatigue area and rail break area (Figure 2).

Figure 2. Typical shape of a steel surface after break caused by squat [6]

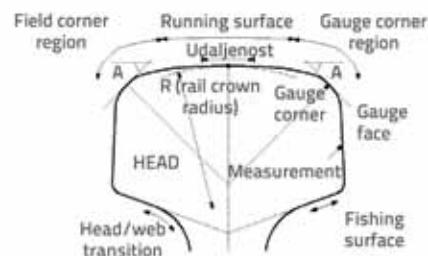
The occurrence of squats is directly caused by excessive dynamic wheel/rail contact force due to vertical irregularities on the running surface of the rail. Squat zones are shown in Figure 4: running surface within the rail crown radius (R) and the gauge corner region.

Figure 4. Squat zones in rail head: running surface

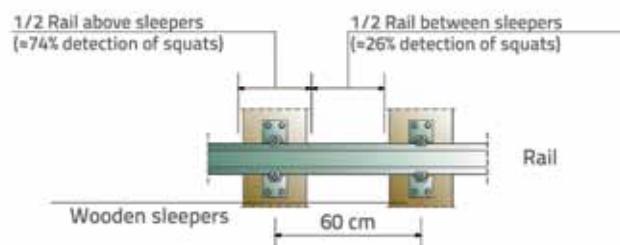
Visual inspection on the Vrbnica – Bar railway section [8] has confirmed the correlation between squat locations and the stiffness and damping characteristics of the track. Approximately 75 % of all squats were registered on the ½ of the rails centered on sleepers, and the remaining squats were noted on the other ½ of the rails in the centre between two sleepers (Figure 5).

Figure 5. Squat locations on track

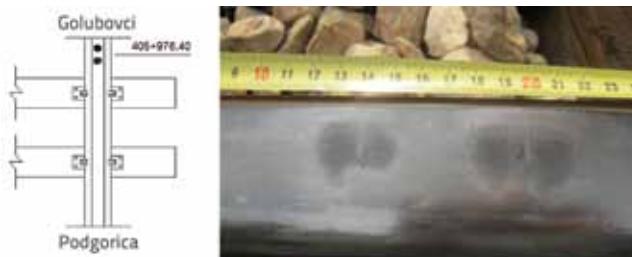
Appearance of squat defects in weld zones (about 10 – 15 % of the total) on the Vrbanica – Bar railway section [8] can be explained by inhomogeneity of material exposed to high temperatures during the welding process, and geometry imperfections at the cross section of the weld [9, 10]. Squats on rails have been located randomly, and they occur in great numbers (Figure 8), which is quite dangerous because of the risk of multiple fractures with significant gaps.

Figure 8. Multiple squat defect (typically shaped as "lungs")
