Analysis of building damage caused by earthquakes in Eastern Turkey

Professional paper

Cumhuri Coşgun, Ahmet Anil Dindar, Edip Seçkin, Yusuf Hatay Önen

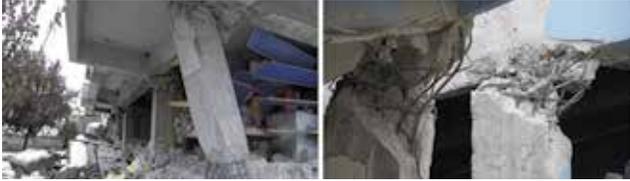
Structural elements are designed to withstand static and dynamic forces under various circumstances such as excessive gravity loads and earthquakes. It would be desirable for permanent damage to occur at the end of the beams, while the columns should remain elastically intact. In this way, the total collapse of the buildings would be prevented and people inside the building could be evacuated without any loss. However, the observations regarding earthquakes that hit the city of Van and the town of Erciř have revealed that most of the heavily damaged buildings have the RC beams which are stronger than the columns, contrary to the above mentioned principle. This proves that acceptable structural behaviour has not been provided for in the design and construction of buildings in this area.

Figure 9. Examples of plastic rotations at the end of columns instead of beams in Erciş

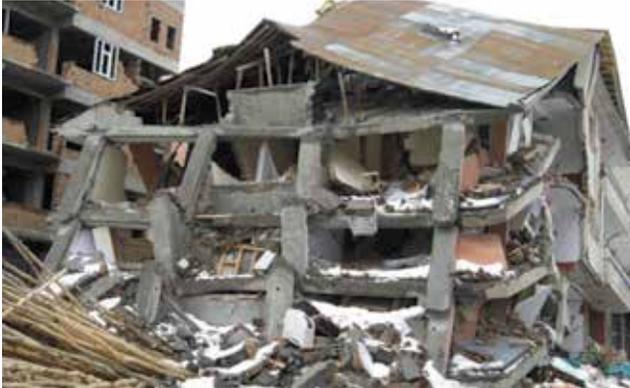
Figure 10. Total collapse of a building in Erciş due to sway mechanism after plastic rotation at the end of each column of individual storeys

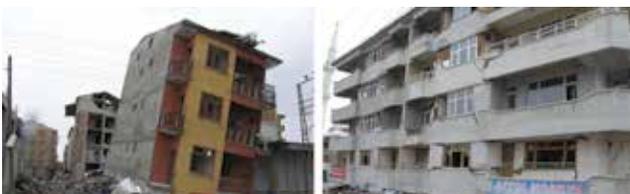
Figure 12. Collapse of two buildings due to soft storey effect at the ground floor level in Erciş

Buildings adjacent to streets are usually used for both commercial and residential purposes. To provide enough space at the ground floor, the storey height is generally higher than that of the upper floors and also, there are no infill walls at the street side of the ground floor, because of the need to provide for better visibility of the commercial area. However, this fact causes a soft storey effect in case of multi-storey buildings. Due to the lack of lateral stability at the ground floor level, the building sways up to the limit of the lateral deformation capacity of the columns at the ground floor, resulting in collapse of the entire soft storey, Figure 12.

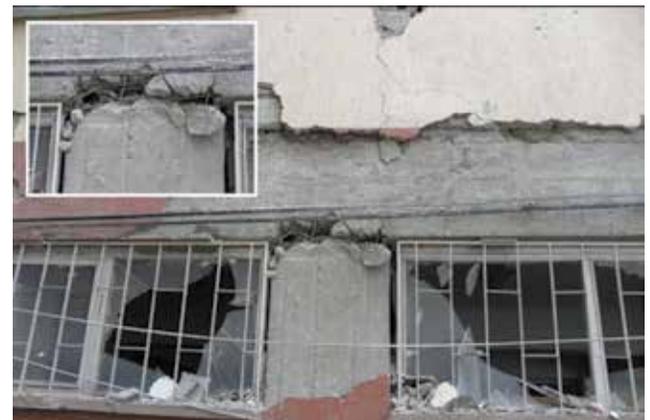
Modern seismic design codes prevent shear failure of columns by prescribing a certain amount of confinement around longitudinal rebars. However, if the shear span of flexural elements is shortened for some construction related reasons, the structural element is prone to excessive shear forces rather than flexural forces. As a result, during the quakes, the diagonal shear cracks occur along the free height of the flexural element, Figure 13. Such damage could create undesirable mechanisms at the building's floors.

Figure 13. Shear failure at the top of the column due to short shear span in Van

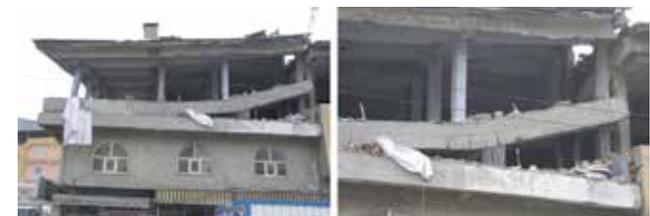
The buildings constructed in the downtown of Van and Erciş are row house style buildings situated along both sides of the streets. Unfortunately, the lack of regulations on the height of buildings creates a practical problem of having different story heights, as shown in Figure 14. Hence, during ground shaking, the rigid floor of one building may hammer at the middle of the columns of the adjacent building. Such lateral forces acting on the columns lead to disastrous drop of the column stability and, accordingly, to the collapse of the entire slab above.

Figure 14. Partial collapse of the slab due to pounding in Erciş

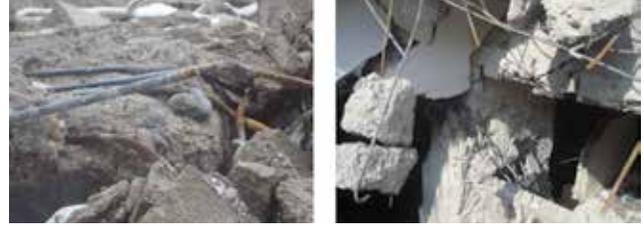
The study of the damaged or collapsed buildings has revealed that both the longitudinal and lateral reinforcement details at structural elements are not consistent with the code based regulations. For example, the Turkish Earthquake Code (TEC2007) strictly forbids the use of plain rebars as longitudinal reinforcement in earthquake-prone areas. However, most of the multistorey RC buildings that collapsed in Van and Erciş suffered from the poor-bonding problem, Figure 27.

Figure 27. The use of plain reinforcement as longitudinal rebars in RC beams and columns

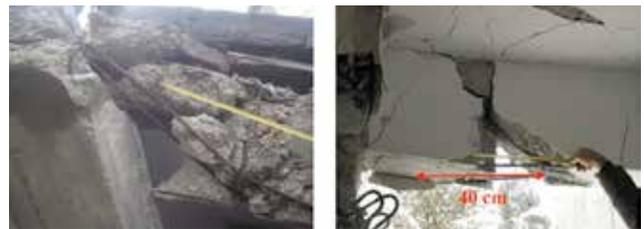
In case of reversed cyclic deformations, the confinement of the RC beams and columns is very crucial for maintaining adequate resistance of longitudinal rebars to shear forces. Therefore, lateral reinforcement intervals along RC elements are limited to 10-20 cm and 15 cm for the columns and beams, respectively, [10], Figure 28. In the majority of the damaged or collapsed buildings, structural elements did not have a sufficient quantity of lateral reinforcement. In addition, the hooks at the end of the rebars were also either missing or were not arranged at 135 degrees as required by the codes, Figure 29.

Figure 28. Inadequate lateral reinforcement intervals

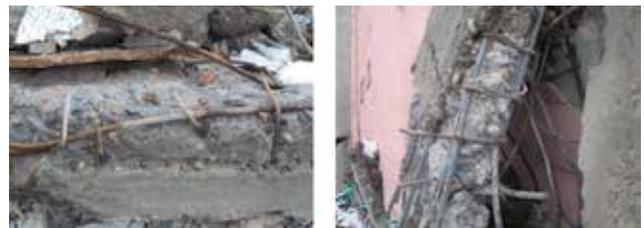
Figure 29. Poor hook arrangements at the end of lateral confinement bars

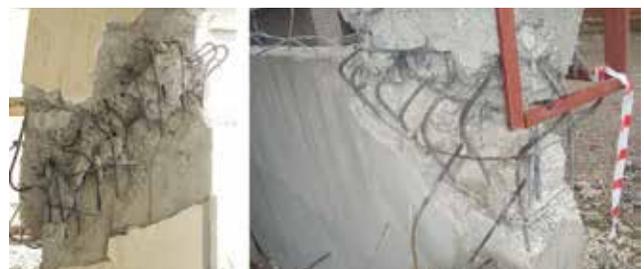
In case of structural elements with insufficient lateral rebar intervals, the buckling of longitudinal rebars may occur when such elements are subjected to severe shear forces, Figure 30.

Figure 30. Shear damage and buckling of longitudinal reinforcement due to insufficient lateral rebar interval
