Analysis of Water Treatment Plant Operation in Ilijaš Municipality

Professional paper

The operation of the Karašnica Water Treatment Plant, forming part of the water system in Ilijaš Municipality, in Bosnia and Herzegovina, is analysed in the paper. Two distinct water treatment lines are described and analysed. The first line consists of an internal circular settling tank and rapid sand gravity filters, while the second line consists of an external circular settling tank and pressure filters. In order to evaluate operating efficiency, a tour of the system facilities was made, interviews with the employees were conducted, the existing documentation was examined, and additional physicochemical and bacteriological analyses of appropriate water samples were conducted. Following analysis of all available data, appropriate conclusions and significant recommendations were made toward more efficient operation of the water treatment plant.

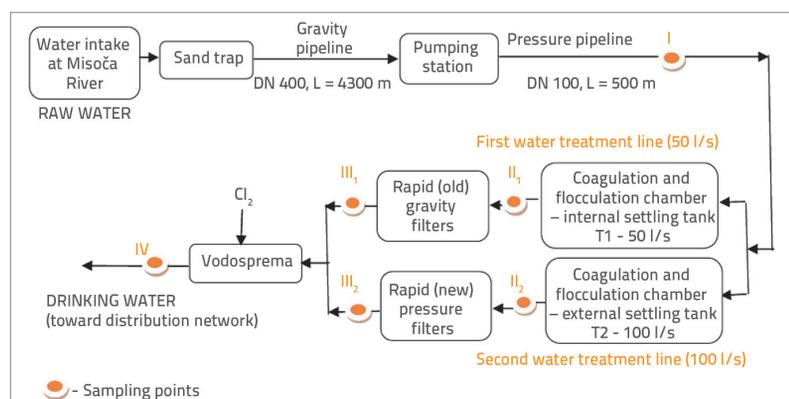
Figure 1. Block diagram of the water treatment technology at the water supply system in Ilijaš municipality

The water supply in the central part of the Ilijaš Municipality is operated via the system managed by the public utility company Vodostan d.o.o. based in Ilijaš. The water supply system is composed of the following facilities and equipment (Figure 1):

The quality of raw water at the intake point in the Misoča River does not comply with some parameters prescribed by the Byelaw [1]. and so the public utility company Vodostan from Ilijaš, in its capacity as the operator of this plant, applies appropriate water treatment measures. The treatment begins already at the surface water intake at the Misoča River where, within the intake and next to it, appropriate facilities were built in order to ensure an efficient water intake and an appropriate pre-treatment, all aimed at relieving the pressure from the water plant itself. Water intake and pre-treatment facilities are described in Section 2.1. Water treatment continues at the Karašnica Plant, with the total capacity of 150 l/s. The block diagram of the water treatment technology next to the water intake and at the plant itself is presented in Figure 1.

take place in integrated coagulation and flocculation chambers that have been built next to circular settling tanks (Figure 1). The previously used aluminium sulphate and polyelectrolyte – polyacrylamide (PAA) have been replaced by a new coagulant/flocculent, i.e. by polyaluminium chloride (PAC). According to plant employees, PAC has proven to be highly efficient [13]. In effect, as a polyvalent non-organic polymer of high zeta potential, PAC presents numerous advantages as compared to ALUM and PAA: it acts both as coagulant and flocculent, it regulates the pH value, it is simpler to use, its mass consumption is lower, and so the quantity of deposit/sludge is much lower and, finally, it is more efficient and rapid in eliminating turbidity. In addition, the use of PAA presents a potential hazard as, in greater concentrations, it acts as a cumulative neurotoxin and complicates washing of filters. *Sedimentation.* Two circular settling tanks with vertical flow of water, 150 l/s in capacity (Figure 2) are used, during preparation of drinking water, for separating from water the floccules created by coagulation and flocculation. The internal settling tank (T1) in the first line of treatment exhibits a capacity of 50 l/s and is situated in the central facility, while the second external open settling tank (T2), belonging to the second line of treatment, has a capacity of 100 l/s. After the clarification process, the water is supplied via a pump system to the filtration unit.

| Test parameter | Unit | Reference value (Byelaw [1]) | Measuring points (marked in Figure 1) | | | | | |

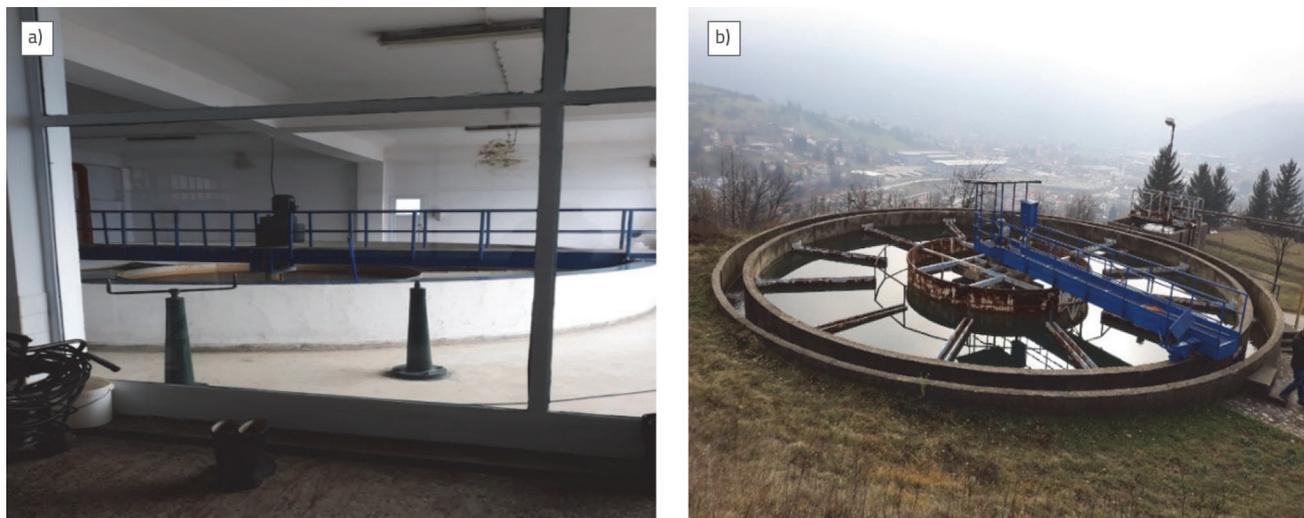
Figure 2. Circular settling tanks at Karašnica plant: (I) internal settling tank (T1) with a capacity of 50 l/s (II) external settling tank (T2) with a capacity of 100 l/s

The preparation of water for sedimentation starts by PAC proportioning in the mixing chamber situated next to the settling tank. This is followed by sedimentation of water at two parallel lines. At the first line (line I) the sedimentation is operated via the internal settling tank T1. By sedimentation of water at the internal settling tank T1 (measurement point II1 (Figure 1); first line (Figure 5)), the initial turbidity of the sample taken on 5 February 2019 was reduced from initial 18 °NTU to 5.2 °NTU, and so 12.8 °NTU is removed at the settling tank T1. The turbidity of the sample taken on 21 May 2019 was reduced from initial 5.6 °NTU to 2.6 °NTU, and so 3.0 °NTU was removed by the settling tank T1 in this case. It can be noticed that the efficiency of the settling tank T1 varies depending on the initial turbidity, as in the first case 12.8 °NTU was removed, while only 3.0 °NTU was removed in the second case. Of course, this is the result of the quantity of PAC added to the water, which is added depending on the turbidity of the influent [13]. In effect, greater initial turbidity calls for greater quantity of chemicals, and hence the turbidity lowering was more pronounced during the measurement conducted on 5 February 2019, when the initial turbidity amounted to 18 °NTU.

At the second line, the sedimentation was operated via the external settling tank T2. By sedimentation of water at the external settling tank T2, the initial turbidity of the sample taken on 5 February 2019 was reduced from initial 18 °NTU to 4.4 °NTU, and so 13.6 °NTU was removed at the settling tank T2 (Figure 5). The turbidity of the sample taken on 21 May 2019 was reduced from initial 5.6 °NTU to 3.2 °NTU, and so 2.4 °NTU was removed by the settling tank T2 in this case. Just like in the case of the settling tank T1, greater efficiency of the settling tank T2 in the case of the first sample (turbidity: 18 °NTU) is due to greater quantity of chemicals (PAC) added.

An average decrease in turbidity at the internal settling tank T1 (12.8 and 3.0 °NTU) is 7.9 °NTU, while it amounts to 8.0 °NTU (13.6 and 2.4 °NTU) for the external settling tank T2. It can therefore be concluded that the turbidity abatement efficiency of the two settling tanks is almost the same.

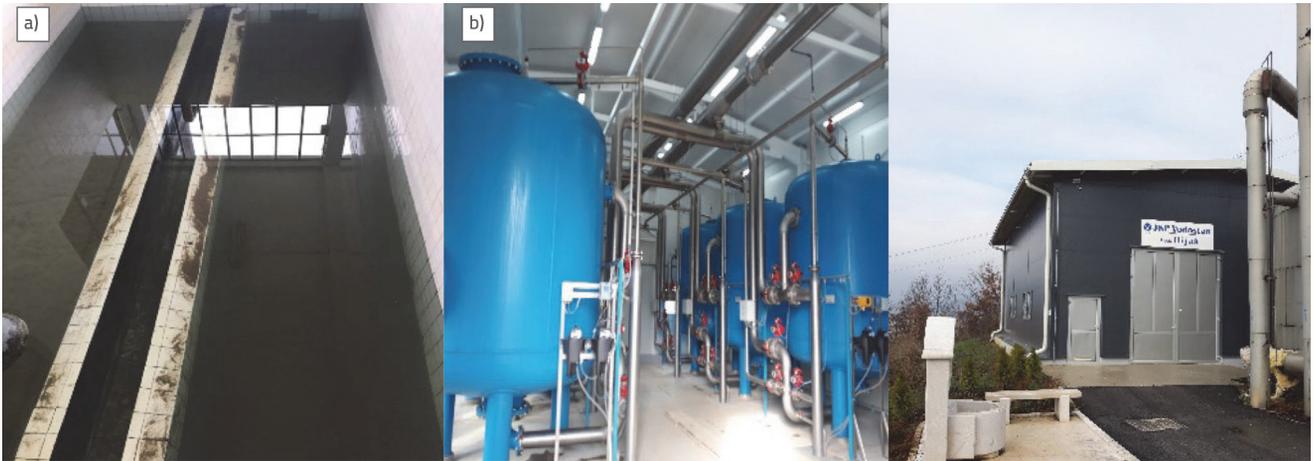
Figure 3. Filters situated in Karašnica plant: a) gravity filter b) filters under pressure and facility accommodating these filters

filtration systems. These filtration systems are presented in Figure 3, while the basic properties of these filters are given in Table 1. At the first treatment line (Figure 1) the filtration system is based on rapid gravity filters, 50 l/s in total capacity. These filters are situated in the enclosed central facility, and the water is carried to the filters from the internal settling tank (T1). Gravity filters are filled with quartz sand, measuring 0.5–1.2 mm in grain size, and 100 cm in layer thickness. There are three filtration fields, each measuring 20 square meters in area, and so the total area of gravity fields is 60 square meters. The filtration of water under pressure is a newly introduced filtration process at the Karašnica plant. After settlement, the water is carried from the external settling tank T2 (Figure 1 (second line)) to six vertical filtration vessels – modules, each with the operatic capacity ranging from 7 l/s to 20 l/s, which is regulated with a gate that can be operated either manually or automatically. During the filtration vessel washing, the gate closes itself so as to avoid contamination of water in the water tank [14]. Filters are made of special steel destined for vessels under pressure, and they have an appropriate two-sided corrosion protection [5]. The filter fill material, formed of quartz sand and garnet, is 120 cm in total thickness. The garnet between the support fill and filtering fill eliminates the problem of gravel overturning and disturbance of fill material when filters are washed under pressure.

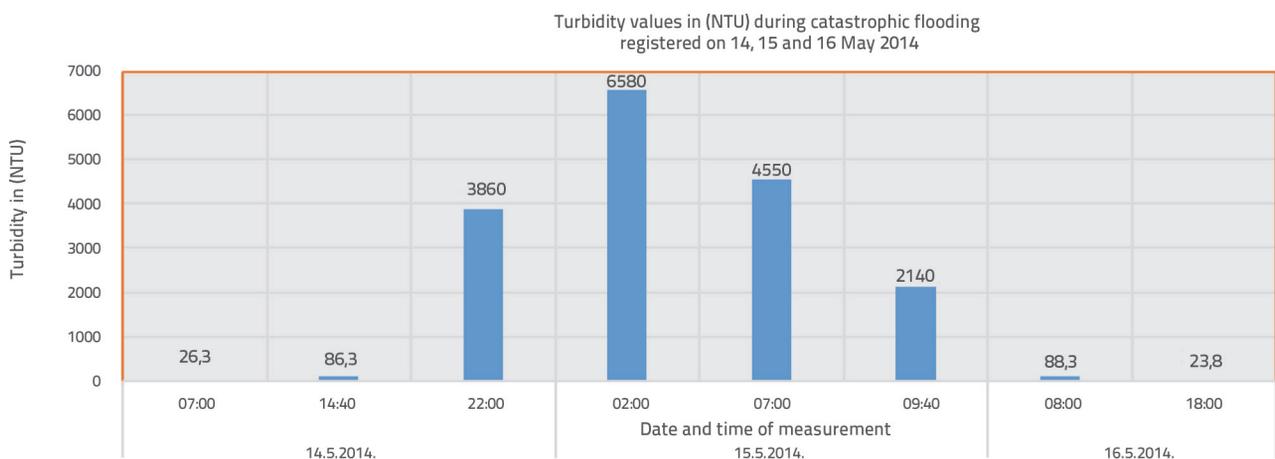
Figure 4. Diagram showing rise and fall in raw water turbidity at the measuring point in front of the Karašnica Plant

highest level of turbidity measured to this date is 8290°NTU [14]. In addition, turbidity durations and levels registered at the Misoča River in the period of catastrophic floods (precipitation) that affected Bosnia and Herzegovina in May 2014 are presented in Figure 3.

After analysis of results obtained by turbidity measurements conducted by the operator JKP Vodostan Ilijaš [10, 14], it was established that the turbidity value increases and decreases more rapidly in the period of precipitation following longer dry periods. On the other hand, it should be noted that during a long-lasting rain period registered in May 2014, turbidity values actually increased and decreased more slowly, as can be seen in Figure 4. These are extreme turbidity values when the plant operation is stopped until the turbidity values return to acceptable levels and, according to the data provided by the operators, these values are: turbidity should be less than 40 °NTU at the entry to the plant, and less than 20 NTU and the entry to the filters (Table 2). An average raw water turbidity prior to entry to the Karašnica Plant is always above the maximum allowable concentration (MDK), which amounts to 1.0 °NTU. Thus, for instance, in 2017, an average measured turbidity of raw water prior to the entry to Karašnica plant amounted to 21.82 °NTU [10].
