Dynamic identification of three 19th century churches in Turkey

Professional paper

Dereköy and Aydınpinar churches in Bursa and Ballıpınar Church in Balıkesir, all built in the 19th century, are examined in this paper by means of experimental and finite element analyses. The compressive and shear strength of the walls is calculated using the flat-jack and shear tests. Natural frequencies and mode shapes of the entire structure and individual walls in x direction are analysed by means of the Operational Modal Analysis tests. The data obtained from all experimental approaches are used in the finite element models. The experimental and finite element analysis results are compared.

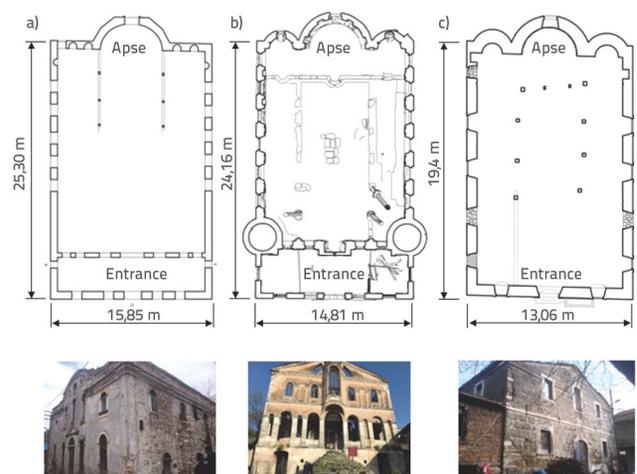
Figure 1. Plan views and photos of entrance facades of: a) Aydınpinar Church, b) Dereköy Church, and c) Ballıpınar Church

As a result of abandon and neglect, the studied churches have not been in use for more than two decades now. The roof of the churches and all timber pillars and beams related to the roof structure collapsed, so that only the load bearing walls (outer walls) are still standing today. Architectural features of the churches were examined in terms of construction dates, material usage, dimensions of the churches, and height of the walls. Aydınpinar Church was built between 1846 and 1870. Brick, rubble stone, and cut stone materials were used in the construction of the walls. Lime mortar was used as binder. The structure occupies an area of 15,85 x 25,30m. Outside walls are 0.70 m in average thickness. The wall height is 7.82 m. Dereköy Church was built in 1857.

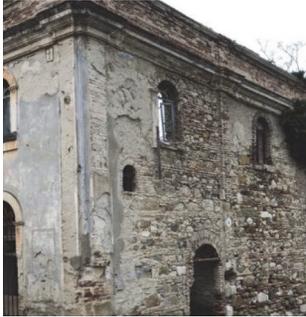
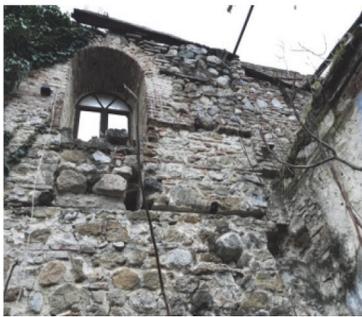
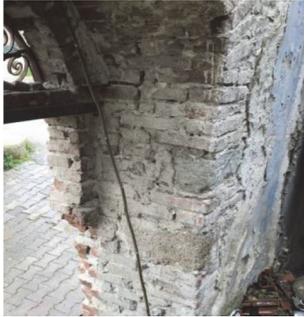
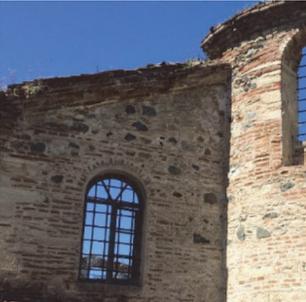
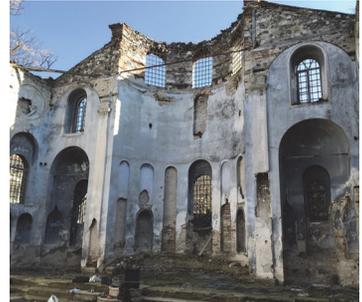
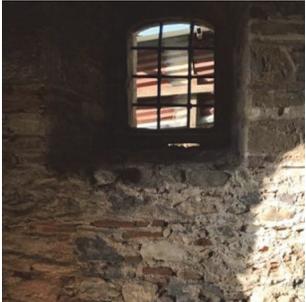
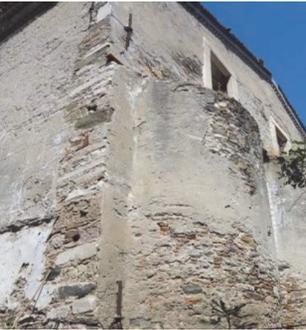
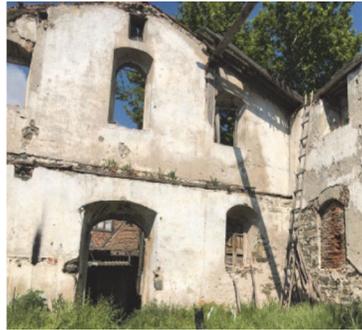
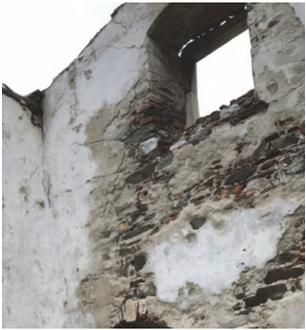
Table 1. Photographs of exterior, interior and wall section of churches

Churches	Exterior of the church	Interior of the church	Wall section
Aydınpinar Church

x 24,16 m. Outside walls are 0.85 m in average thickness, and the wall height is 9.00 m. Ballıpinar Church was built in 1895. The structure occupies an area of 13,06 x 19,04 m. Stone and brick were used in the construction of the walls. The walls are 0.80 m in average thickness, and the wall height is 6.80 m. The plan views and photographs of the entrance facades of the churches are presented in Figure 1 [21, 22]. Photographs of the exterior, interior and wall section of the churches are presented in Table 1.

where P_h is the maximum force applied by the hydraulic pump and A_j is the gross area of the upper and lower bed joints [24]. Mechanical properties such as compressive stress, shear stress and elastic moduli of church walls calculated by in-situ tests are presented in Table 2. The plaster of the outer walls has fallen off and the open air conditions and moisture made the mortar weak. Therefore, the walls have significantly lost their mechanical properties.

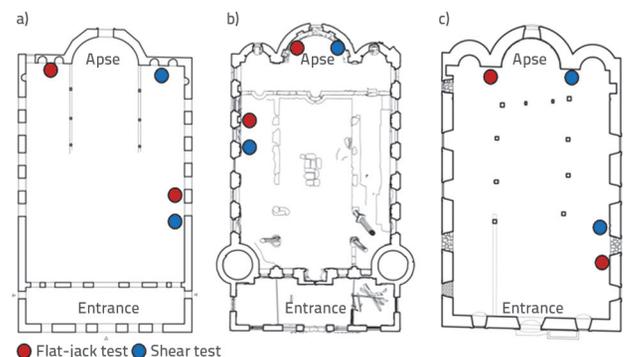
Figure 2. Flat-jack and shear test locations: a) Aydınpinar Church, b) Dereköy Church and c) Ballıpinar Church

Average results of two experimental tests (one for each wall in the x and y directions) were registered during the flat-jack and shear tests. Test locations for each church are shown in Figure 2.

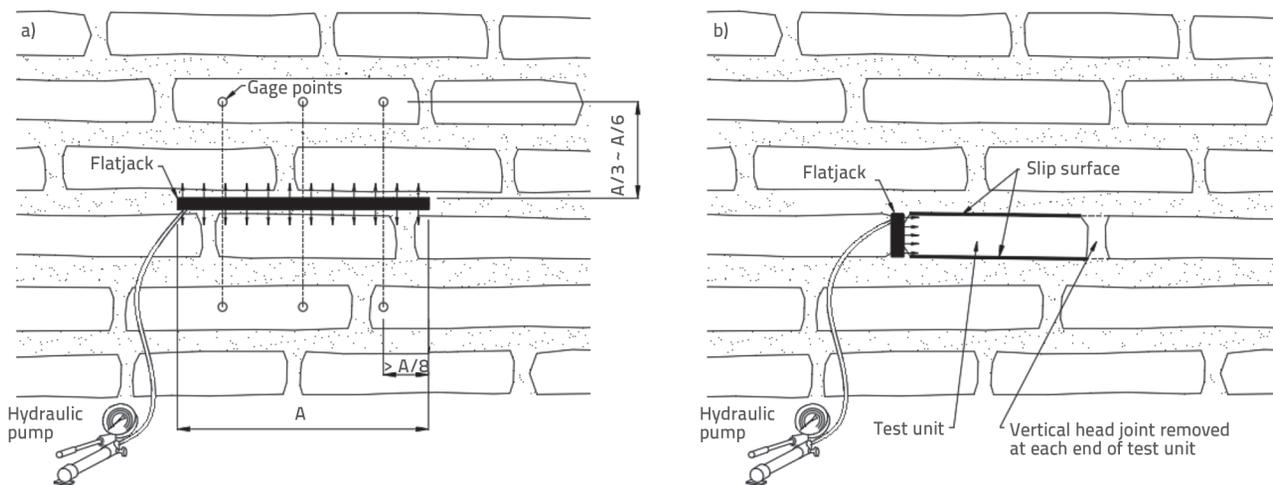
Figure 3. Flat-jack and shear test: a) Single flat-jack test setup b) Shear test setup

the compressive stress and elastic modulus of the walls. In this test method, a slot was cut in the mortar layer and a flat jack was placed inside the slot. The stress and displacement values of composite walls were continuously read while the hydraulic oil pressure pump (bar and psi) inflated the flatjack [23]. The method C was used according to ASTM C1531-09 in shear tests [24]. In this method, a small flat jack is horizontally inserted at one end of the test unit. Hydraulic oil pressure is applied until a crack appears or slip occurs.

A detailed presentation of the flat-jack and shear test setups, including the displacement measurement, flat-jack placement, and slip surfaces, is given in Figure 3. The calculation of compressive stress, elastic modulus, and shear stress is presented as follows in Eqs. (1) and (2).

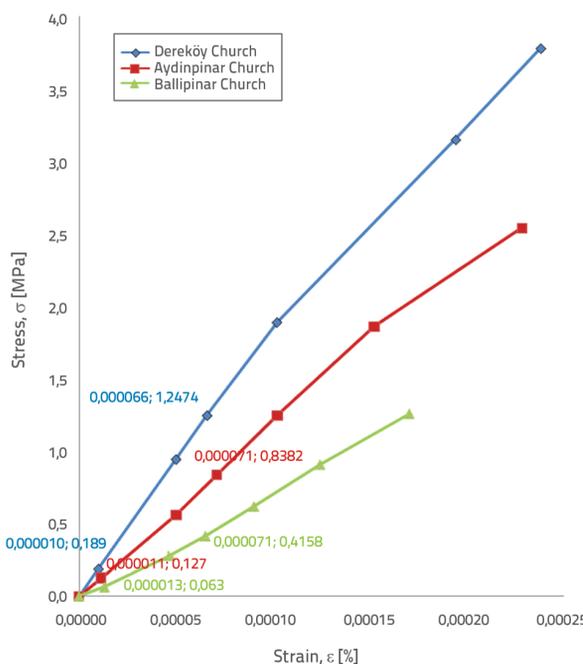
Figure 4. Stress-strain diagram of composite walls

Elastic moduli of composite walls were calculated using end points of 0.05 and 0.33 chord modulus of elasticity values [25]. The stress-strain diagram of composite walls is presented in Figure 4.

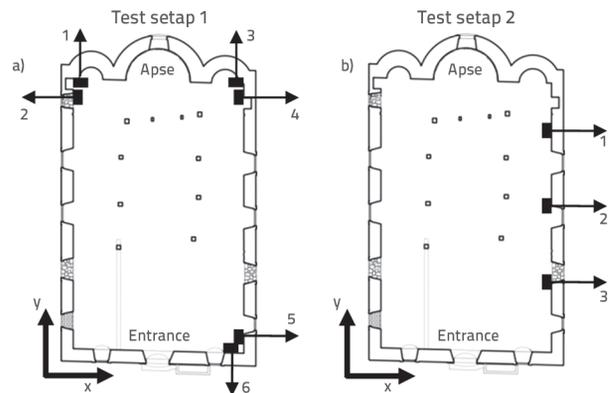
Figure 5. Plan view of sensor orientation for a) test setup 1, and b) test setup 2

orientations were carefully checked for all church walls. For all churches, tests were performed both on the entire structure and on one of the individual walls in x direction. Accelerometers were placed approximately 1,5 metres under the elevation of the roof. The orientation of sensors and the test setup were the same for all churches, as shown in Figure 5 for Ballıpınar Church. Sensor placement and test equipment are shown in Figure 6.

The results for the test setup 1 were examined. It was observed that there were some difficulties in determining frequencies of the entire structure. The main problem was the absence of the roof and the loss of all horizontal connections between the walls. Therefore, it was seen that the walls do not act as a structure but rather as independent walls. The other problem was the non-symmetrical wall construction. The bending mode frequencies of the walls in x direction (north and south wall) were determined by OMA tests with good accuracy. The reason for this is thought to be the symmetrical wall construction and the sufficient test data gain from both walls. On the other hand, the bending mode frequencies of walls of the entrance part and the walls of the apse part in y direction (west and east walls) were determined by OMA tests with poor accuracy because

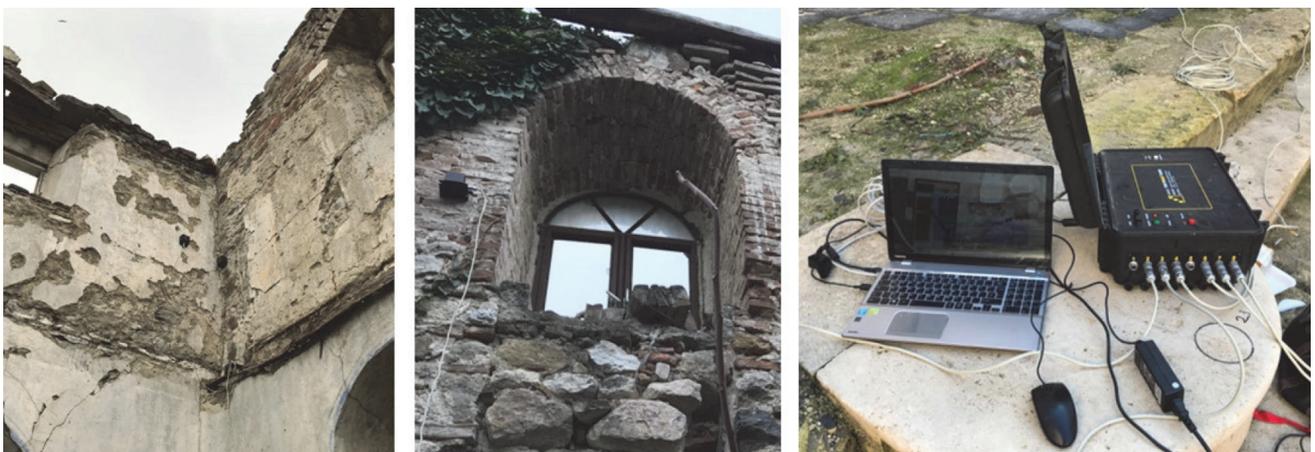
Figure 6. Vibration tests (Sensor placement and test equipment)

2400 mV/g highly sensitive accelerometers were used in the tests. Monoaxial accelerometers having 0.01-200 Hz bandwidths and $\pm 3g$ measurements range were used in this study. The Testbox 2010 data acquisition device with 8 channels was used in dynamic tests [26].

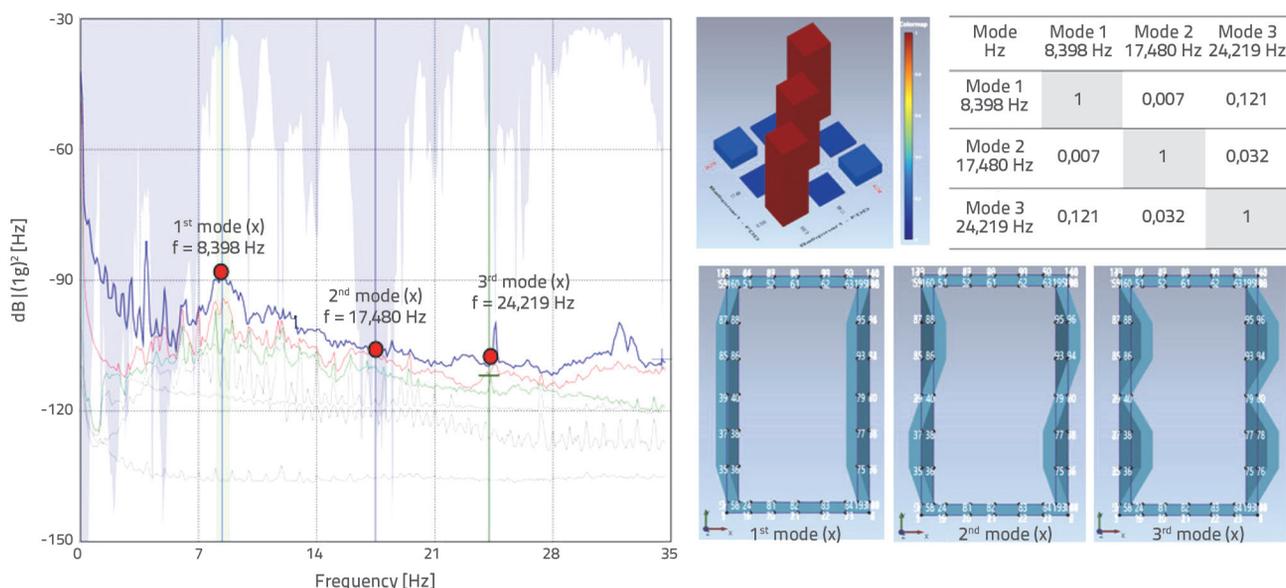
Figure 7. Singular values of spectral densities, 3D and numerical presentation of MAC values of Ballıpinar Church, and the first three bending modes obtained experimentally (Test setup 1)

of the non-symmetrical construction techniques. Differently from walls of the entrance part, half-domes were used in the construction of the walls at the apse part. For these reasons, only the bending modes in x direction were considered, and the orthogonality between the first three bending modes was checked by the modal assurance criteria (MAC). The test setup 2 was also performed by placing three accelerometers in order to determine the first three bending modes of an individual wall of the churches in x direction. Very close frequencies between the test setup 1 and test setup 2 were observed for all churches. In addition, the first three bending mode shapes could be experimentally determined with greater certainty by the test setup 2 compared to the test setup 1. The singular values of the

spectral densities, the 3D and numerical presentation of MAC values, and the first three bending mode shapes in x direction obtained experimentally from test setups for Ballıpinar Church as an example belonging to test setups 1 and 2, are presented in figures 7 and 8.

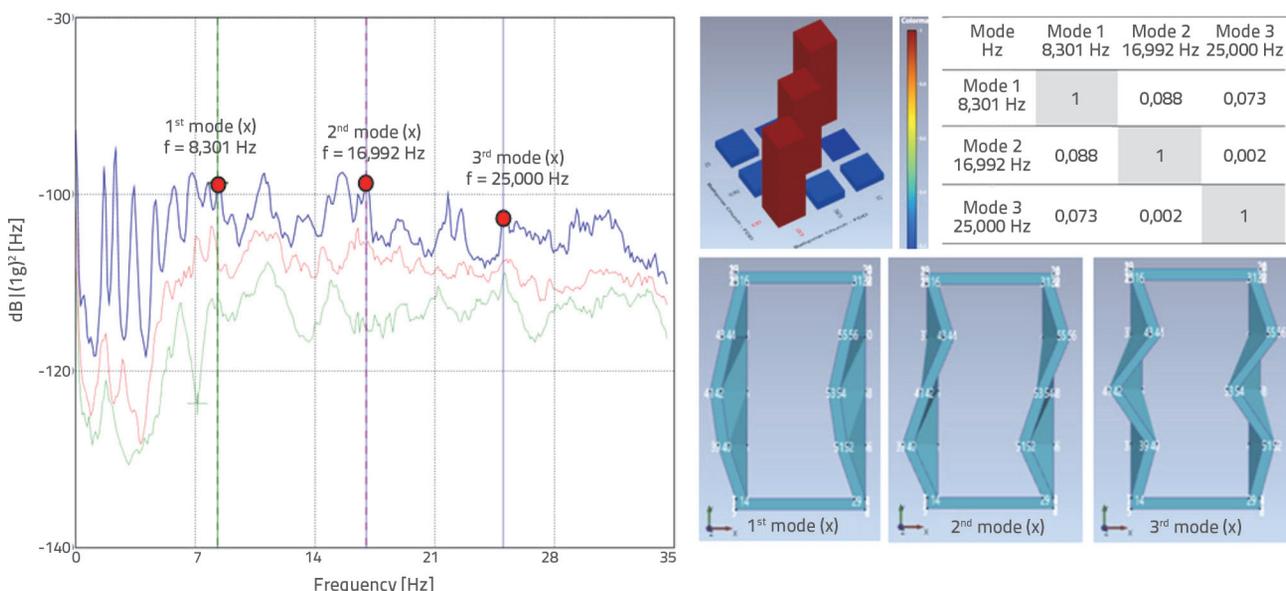
Figure 8. Singular values of spectral densities, 3D and numerical presentation of MAC values of Ballıpinar Church, and the first three bending modes obtained experimentally (Test setup 2)

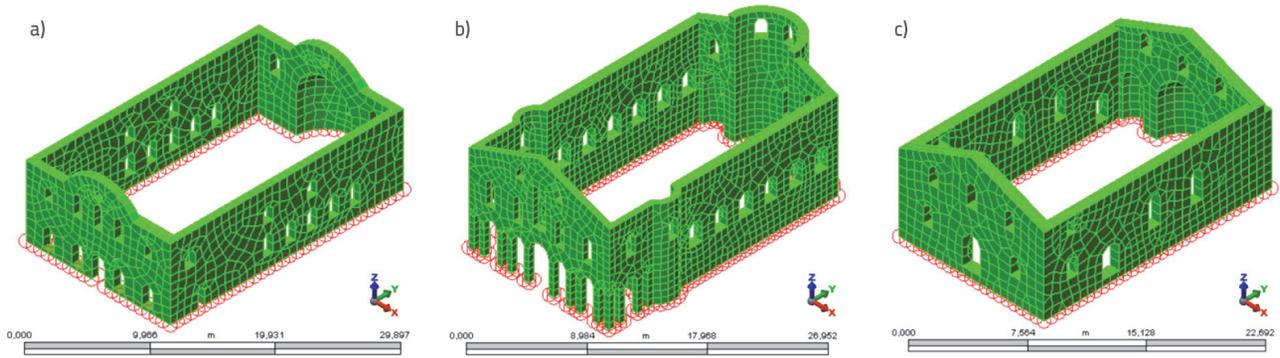
Figure 9. Finite element models for: a) Aydınpinar Church; b) Dereköy Church; c) Ballıpinar Church

Natural frequencies and mode shapes of the churches were investigated by means of the Algor V20 finite element analysis (FEA) programme [27]. Brick, tetrahedra, wedge and pyramid elements, with three degrees of freedom at every node, were generated in the mesh of FEA models (Figure 9). In the finite

element analyses, 2927, 3007 and 5502 solid elements were used in Ballıpinar, Aydınpinar and Dereköy Churches, respectively. After the modal analysis, FEA models were calibrated so as to obtain the real behaviour of the structures. After calibration of finite element models, it was established that the elastic moduli obtained from test results are important for the accuracy of the models. The elastic modulus for Ballıpinar Church obtained by testing was 6 GPa and the value obtained by the FEA calibration was also 6 GPa (0 % error). The elastic modulus for Aydınpinar Church obtained by testing was 19 GPa and the value obtained by FEA calibration was 15 GPa (21 % error). The elastic modulus for Dereköy Church obtained by testing was 12 GPa and the value obtained by FEA calibration was 10 GPa (17 % error). The error between the test results and after FEA calibrations ranges from 0 to 21 percent. The Poisson’s ratio is taken as 0.16 for the masonry walls. Material properties of churches after FEA calibration are presented in Table 3.

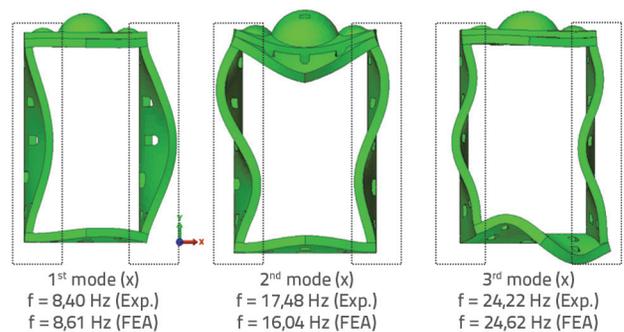
Figure 10. First three bending modes and frequencies of walls in x direction for Ballıpinar Church (experimental study versus finite element analysis)

frequencies of the first three bending modes of the walls in x direction (north and south wall) of Ballıpinar Church obtained from the OMA test setup 1 and the finite element analysis after the calibration is shown in an example given in Figure 10. In this figure, the bending frequencies obtained from the Finite Element Analysis are presented as FEA, while the frequencies from experimental study are presented as Exp.

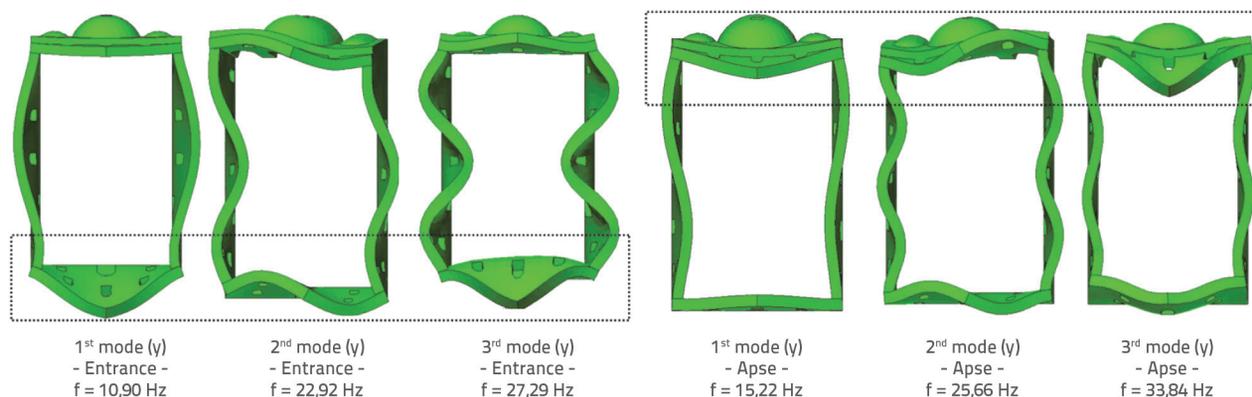
Figure 11. First three bending modes of Ballıpınar Church walls in y direction (entrance wall and apse wall)

The mode frequencies obtained from experimental tests, mode frequencies obtained from finite element analysis, and the error between them, are presented in Table 4. The errors between the results ranged from a minimum of 2 % to a maximum of 8 %. The frequencies of the first three bending modes of walls in y direction (the wall of the entrance part -south wall, and the wall of the apse part - east wall) of Ballıpınar Church obtained from the finite element analysis after the calibration are shown as an example in Figure 11. It can be seen that the bending mode frequencies of the wall of the entrance and the wall of the apse in y direction differ from each other.
