Assessment of the load-bearing capacity of the state road pavement structure

This paper analyzes the condition of the pavement of the Bjelovar northern bypass, the 8.6-kilometer-long section of the state road D28 Predavac-Letičani. This section bypasses the center of the city of Bjelovar and is, in a broader sense, part of the road route from Zagreb to Osijek. The aforementioned section was opened to traffic in 2002. At the time of the field investigation and deflection tests, the designed life span of 20 years was at the very end, and measurements and tests were carried out to assess the condition, or rather, to propose strengthening or reconstruction of the pavement structure. Although the Main Design for the Pavement Rehabilitation was prepared in 2020, due to financial aspects, the constructions are expected to begin in 2025 at the earliest. Given the importance of the data on the basis of which the functional and structural condition of the pavement is determined, the following paper will briefly describe the methods of data collection and, in particular, the non-destructive method using the falling weight device (FWD) that was used to analyze the pavement condition of the Bj

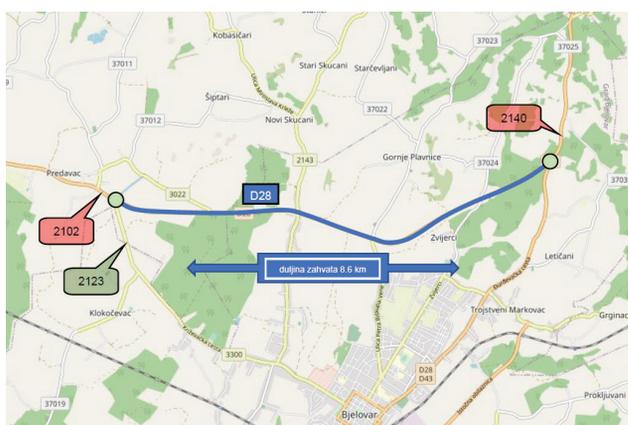
Figure 1. Overview map of the narrow area of D28 Bjelovar bypass with the locations of traffic counters [35]

The traffic counters installed provide information on the structure and number of vehicles by vehicle groups on the observed section. The axle counters on the section in question are located in the immediate vicinity of the planned intervention zone (Figure 1). There are two counting points with automatic continuous counting, marked 2102 Predavac (west of the intervention, approximately 350 m from the start of the route) with an average daily annual traffic (ADAT) of 8,883 vehicles and the counting point marked 2140 Kupinovac (east of the intervention, approximately 500 m from the end of the route in question) with an ADAT of 5140 vehicles. In addition to the above, relevant data is also available from the counting point marked 2123, which is located on the county road Ž3300 in Klokočevac, with data on an ADAT of 5402 vehicles (Figure 1).

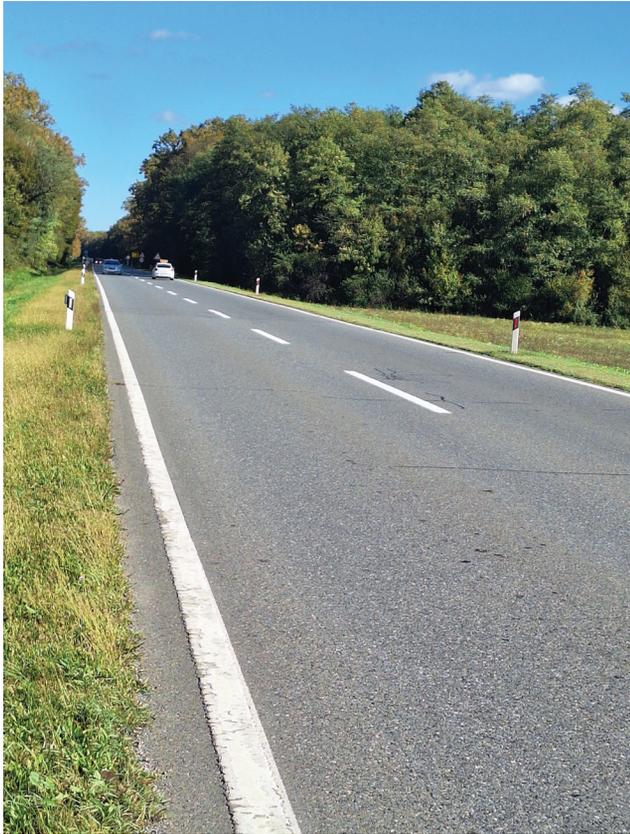
Figure 2. Structural cracks on D28 Bjelovar bypass from km 0+800 to km 2+100

From km 0+800 to km 2+100 on the D28 Bjelovar bypass, structural cracks are prominent, appearing at regular intervals of approximately every ten meters (Figure 2). It is estimated that the primary cause of these structural cracks lies in the cement-stabilized base course, where transverse cracks form during cement hydration. These cracks, influenced by traffic loads and temperature fluctuations, propagate into the upper layers [36].

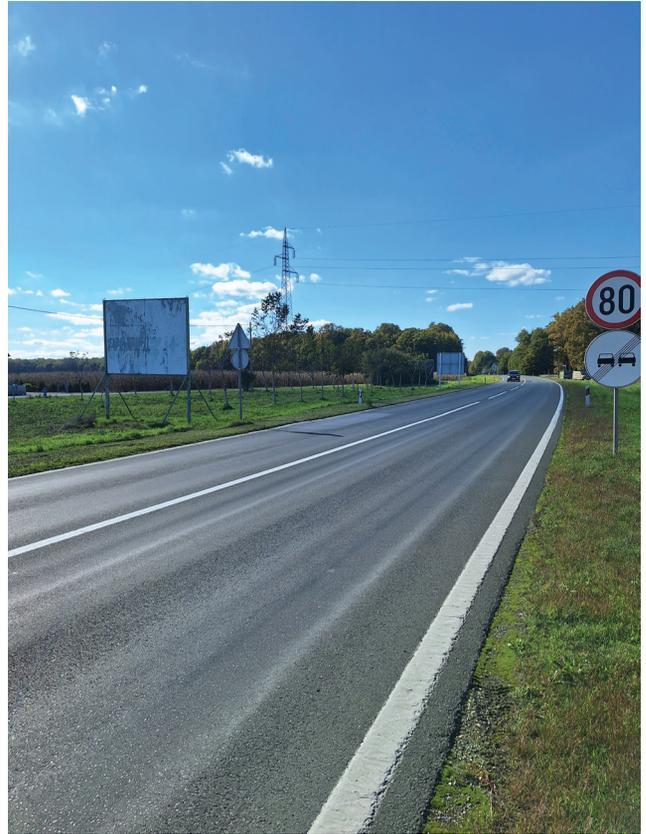
Figure 3. Ruts on D28 Bjelovar bypass from km 2+900 to km 3+300

Ruts are caused by shear failure in the asphalt layer at the wheel track locations (Figure 3). This type of failure is recognized by the ridges that have formed along the depression [37].

Permanent deformations or rutting were observed on subsection C. This can be attributed to the increased share of heavy traffic vehicles that slow down in that section as they approach the roundabout, and it is logical that the SCI parameter is increased (d0 above 160 μm, d2 above 140 μm). According to the results, the CBC base course is also weakened.

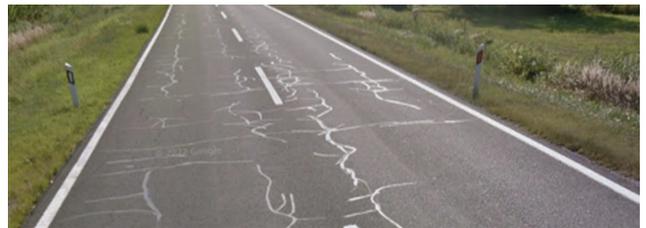
Figure 4. Temperature cracks on D28 Bjelovar bypass from km 7+000 to km 7+500

Figure 4 shows a typical example of temperature cracks caused by fatigue in the asphalt layer on the D28 Bjelovar bypass. During the winter months, asphalt concrete tends to shrink due to low temperatures, which, in principle, is not possible. As a result, tensile stresses develop as temperature drops. The magnitude of these stresses depends on the cooling rate and the type of asphalt mixture, particularly the rheological properties of bitumen. If the tensile stress becomes too high, the pavement will crack at the weakest point. Further cooling of the pavement will lead to additional cracking and the widening of existing cracks. Low-temperature cracks are often the primary reason for pavement maintenance, typically addressed by filling the cracks. When a heavy-duty vehicle passes over a crack, high tensile stresses form at the crack edges due to the absence of load transfer. This issue can worsen in the spring

when moisture infiltrates the cracks, weakening the base layers. These factors indicate that traffic can accelerate the expansion of existing cracks, even though cracks caused by traffic loads are not the primary issue [37].

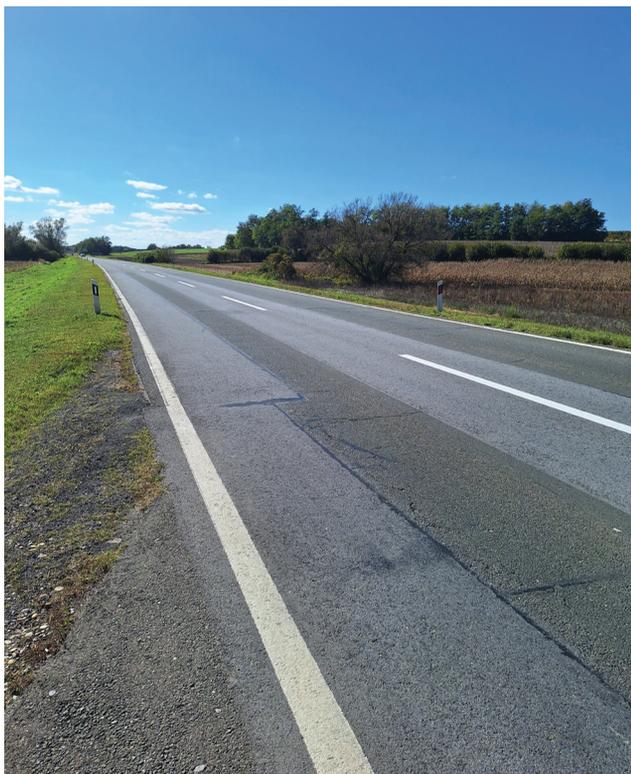
Figure 5. Repairs of local damage to the pavement of D28 Bjelovar bypass from km 5+000 to km 5+500

During regular pavement maintenance on sections of the D28 road, a new thin asphalt layer was applied to replace the existing worn-out layer of the pavement, which had been degraded by temperature microcracks, driving surface with poor grip and pronounced rutting. However, after applying the new thin asphalt layer in smaller segments to replace the old pavement layer affected by structural cracks, poor longitudinal evenness, and pronounced rutting, the new asphalt driving surface quickly developed deformations identical to those in the underlying layer (Figure 5).
