Review of influencing factors of prestressed concrete cylinder pipe durability

Professional paper

A prestressed concrete cylinder pipe (PCCP) is a composite conduit comprising a concrete core, an anti-seepage steel cylinder, prestressed steel wires, and a mortar protective layer. Accidents involving PCCPs can have adverse effects on water supply and industrial production. Therefore, exploring and analysing the factors influencing the durability of PCCPs has significant scientific and practical value. This provides researchers with a more comprehensive perspective on the lifespan and durability of PCCP. This paper systematically summarises and categorises the factors affecting PCCP durability, including chemical erosion, manufacturing defects, improper installation, and poor operational conditions. The main factors and processes influencing PCCP durability are delineated from these four aspects. This paper concludes with recommendations for enhancing PCCP durability. This suggests the need for more suitable concrete additives, improving the composition of the surface coatings on pipelines, researching the longitudinal stress of PCCPs, and conducting non-destructive testing on PCCP

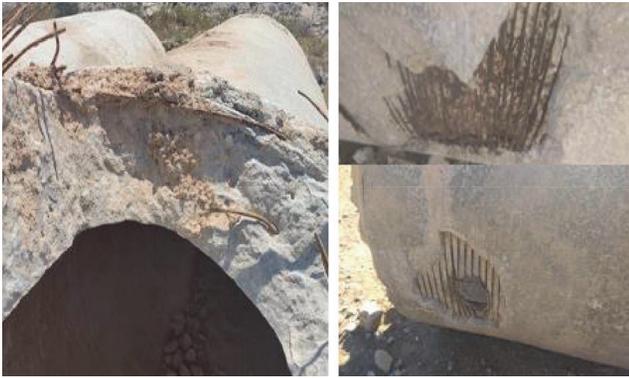
Figure 5. Failed PCCP pipe [6]

One case of chloride ion erosion [6] was reported in 2016 when the authorities in Agadir discovered multiple failure events of a PCCP owing to the extensive corrosion of prestressed steel wires and water hammer action, particularly in the P3 water pipeline, as shown in Figure 5. The main reason for the failure of the PCCP was corrosion of the prestressed steel wire caused by chloride ions. The chloride content in the mortar coating exceeded the corrosion threshold (0.04 % by weight of concrete or 0.2 % by weight of cement); therefore, it caused the corrosion of prestressed steel wires. The study also observed that the erosiveness of the soil and high chloride ion

content of the new PCCP mortar coating indicated that the mortar was contaminated during the mixing process.

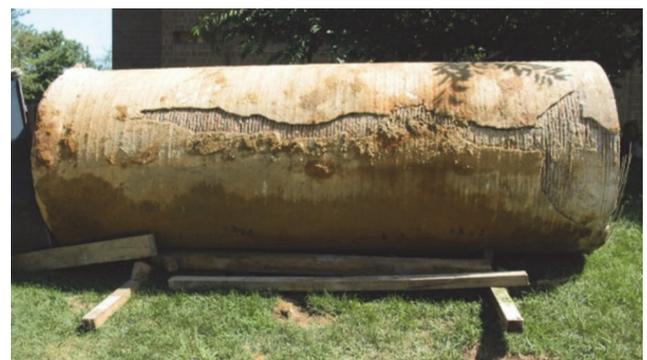
Figure 10. Damaged PCCP [53]

Figure 10 [53] shows a damaged PCCP, the appearance of which shows obvious cracks in the coating with staining owing to corrosion, and all the prestressed tendons were destroyed. One of the contributing factors was the use of a Class A pipeline design for pipelines 51 and 63, instead of the specified Class C design.

The selection of an incorrect pipeline type can also result in pipe bursts in a PCCP. This is because different pipeline types have different quantities of prestressing wires, and choosing a pipeline type that does not conform to the regulations can result in pressures exceeding the specified limits, resulting in accidents. In 2006, in Baltimore County, Maryland [53], an assessment

was conducted on a 48-inch PCCP pipeline located on Kenilworth Avenue. This pipeline experienced two leakage incidents before inspection, and the main range of the 48-inch water transmission system suffered two significant ruptures, causing severe damage to the road and surrounding houses, resulting in the closure of the Kenilworth Drive main road and the shutdown of local schools.

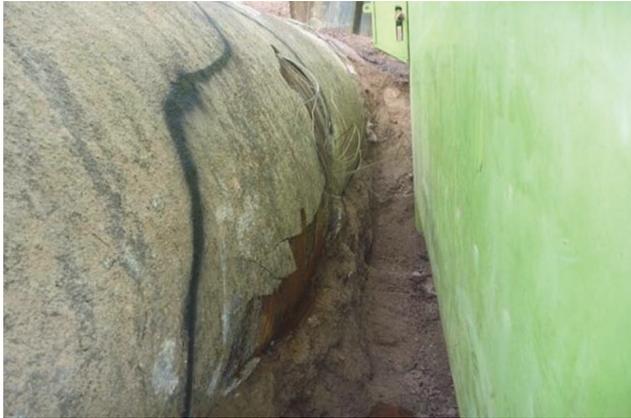
Figure 12. Incipient failure of a 96-inch diameter pipe [57]

Non-compliant bedding conditions subject concrete to superimposed stresses, resulting in mortar cracking [57] and exposing the wires to passivation and corrosion threats. Under extreme conditions, such as placing the pipeline directly on rocks [58], point loading can occur on the pipeline, which significantly exacerbates pipeline failure. Conversely, high-quality bedding can significantly reduce the design strength requirements for pipelines. A classic case occurred on 5 February 1999 when a 24-foot-long segment of a 96-inch main waterline in Tucson's water supply system experienced a severe leak [57], flooding residential areas with 38 million gallons of water. Figure 12 [57] is a photograph of the damaged PCCP. Analysis indicated that the cause of the accident was the installation of clay dams around the pipeline to divert water from the trench to the exterior, resulting in poor bedding conditions.

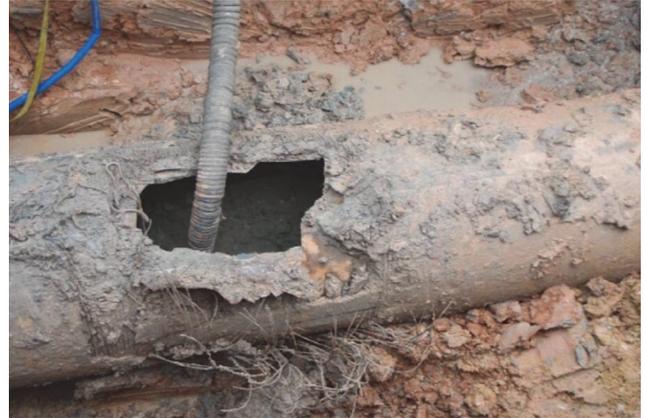
Figure 13. Failed pipe section i [63]

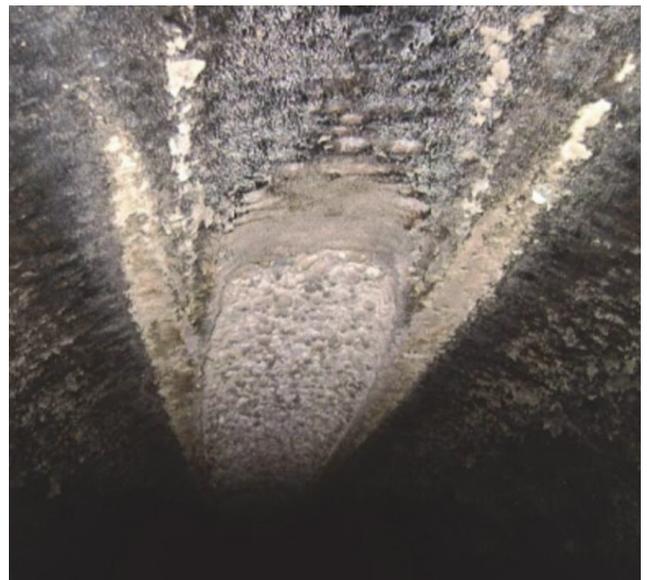
Figure 15. Surface corrosion and exposed aggregates [76]

For example, in 1999, a segment of a 1350 mm diameter sewage pipeline in Regina, Saskatchewan, Canada, experienced failure [76]. Internal inspection results in 2008 indicated that the cause of the accident was an improper internal flow design of the pipeline. The disruption in water flow conditions within the pipeline transitioned from supercritical to subcritical, causing turbulence. The pipeline conveyed sewage with a high hydrogen sulfide content, and under turbulent conditions, the process of hydrogen sulfide changing from liquid to gas was accelerated. This caused a significant accumulation of hydrogen sulfide at the top of the pipe, corroding the inner surface of the concrete, and ultimately resulting in pipeline failure. Figure 15 [76] shows the surface corrosion and exposed aggregates. Figure 16 summarises the aforementioned poor operating conditions.
