Hardness distribution over cross-section of grooved rails

Head hardened rails have been introduced in order to extend the rail-replacement cycles for Zagreb tram tracks. During their precurving, the rail cracking occurred. Hardness tests were performed and tensile strength was calculated to establish whether unusual mechanical properties of rail steel are responsible for the cracking. Tests have shown that hardness values, despite significant variation over the rail cross-section, are higher than the prescribed minimum. It is assumed that rail problems encountered may be due to changes in rail steel microstructure resulting from an increase in rail head hardness during its thermal treatment.

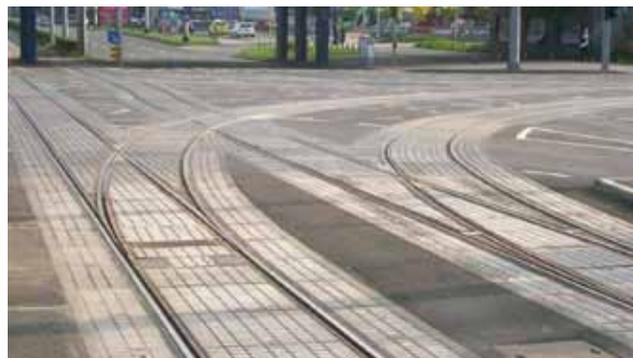
Figure 1. Standard tram track structure in Zagreb

Due to high vertical and/or gauge face rail head wear rate, tracks subjected to very high traffic load, such as the tram tracks in Zagreb (individual tram lines in the city centre are exposed to traffic of 15 million gross tons a year, with the tram vehicle passing frequency of under one minute [3]), and also tracks with high share of small radius curves ($R_{min} \geq 18m$), often call for premature rail replacement. Rail replacement at places where tram corridor is also used by other traffic (Fig. 1) represents the biggest maintenance issue for the Zagreb Municipal Transit System – ZET Ltd. At these

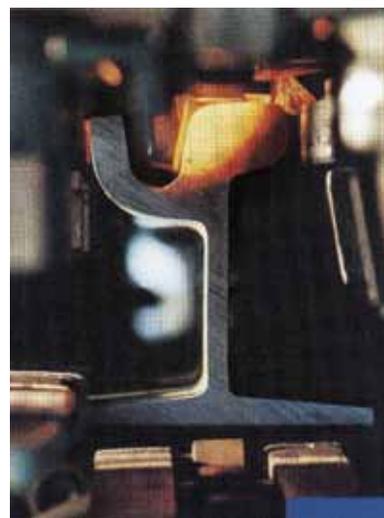
Figure 2. Heat treatment of the grooved rail head [5]

locations, where tram tracks are embedded either in asphalt or in precast concrete plates [4], the organisation of track reconstruction while ensuring an undisturbed operation of other traffic is very complicated if not impossible. In order to extend the rail replacement cycles for Zagreb tram track structures, head hardened (HH) rails have been introduced. There are two main methods of HH rail production: by making modifications in chemical composition of the standard carbon rail steel, or by heat treatment of the rail head (Figure 2. [5]). Foreign experience in the HH rail use shows that increase in rail steel hardness at the wheel-rail contact is a highly efficient and cost-effective method for extending the rail life cycle, because the wear resistance of rails is in that case increased by as many as three times [6]. This positive experience in HH rail use was severely compromised after the ZET Ltd. purchased heat treated HH Ri-60 rails, steel grade 700 and 900A, for which the qualifying test results, provided by the manufacturer, showed satisfactory values of rail steel mechanical properties. First problems occurred during rail precuring (rails were cracking). Rails that were installed in the tracks soon showed significant signs of wear. According to agreement with ZET Ltd., the Ministry of Transport conducted its own tests in order to

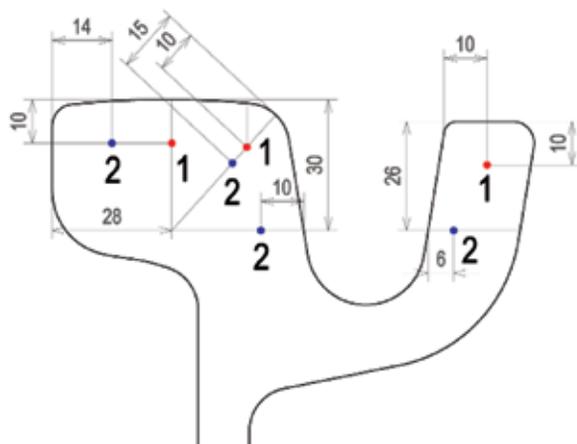
Figure 3. Positions of hardness measurements in the head hardened rail cross section [9]

In case of HH rails, mechanical properties of steel at rail web and base must comply with prescribed values for the basic steel grade given in Table 1 [7, 8], while the steel in the head area (Figure 3) must meet additional requirements shown in Table 2 [9].

Hardness measurements were conducted at measurement points 1 and 2 of the rail head defined by [9], at three additional points at the running surface (marked as Ha and Hb), and at the rail guide (G) (Figure 3 and 4). Measurement points marked as 1a, 1b, and 1c are located 10 mm below the running surface, which is the zone of maximum tangential stresses in the rail cross-section. The measurement point 2a location corresponds to the location of sampling for the tensile strength testing. In total, more than a hundred hardness measurements were carried out at these measurement points.

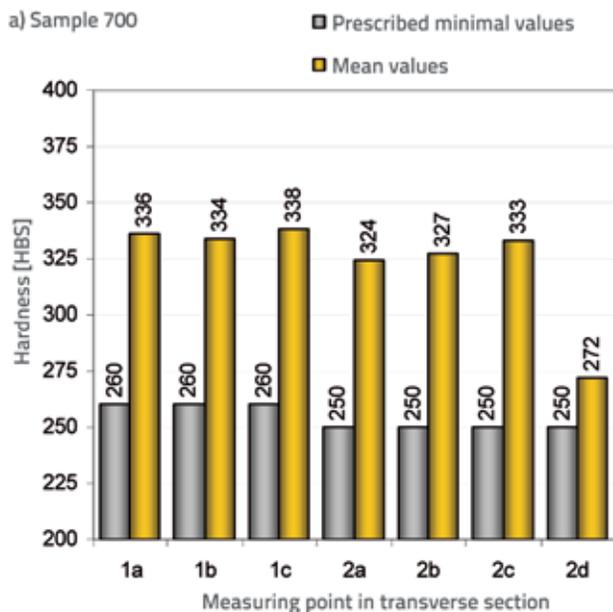
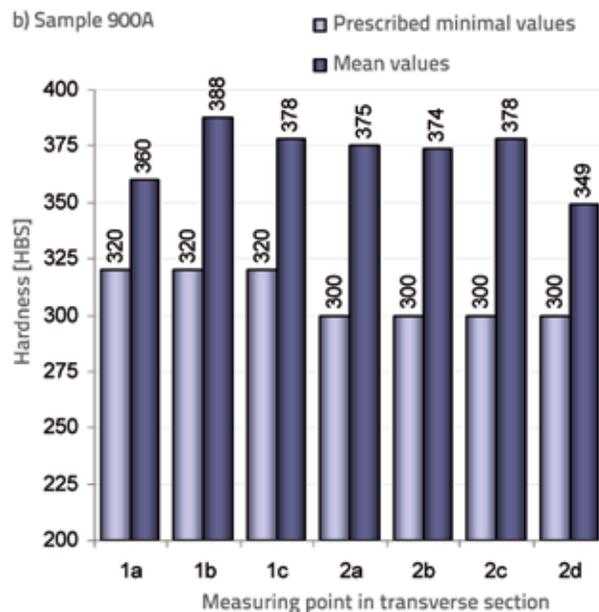
Figure 5. Mean hardness values at the rail head cross-section: a) samples 700-1 and 700-2; b) samples 900A-1 and 900A-2

An overview of mean hardness values, calculated on the basis of values measured at the points 1 and 2, as related to prescribed minimum values given in Table 2, is given in Figure 5. The difference between the mean and prescribed minimum hardness values for each measurement point, expressed as percentage, is given in Figure 6. It can be seen that all mean hardness values are greater than prescribed minimum values, with an average 25 % increase in hardness. The biggest difference in all four cases was observed at the measurement point 2c, where mean hardness values exceed the prescribed minimum by 33 % (samples 700) or 26 % (samples 900A).

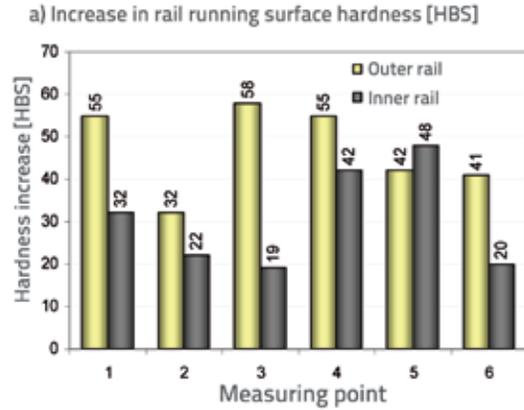
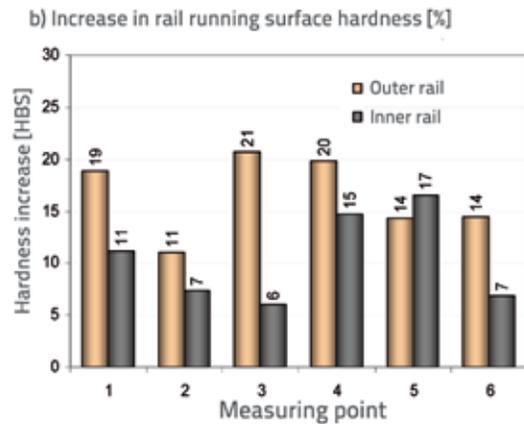
Figure 9. Increase in the rail running surface hardness due to cold forging

Cold forging induces hardening of the rail running surface due to continuous passing of vehicle wheels. The increase in hardness values depends on the magnitude of the total travel load, axle load, rail steel quality, wheel radius, etc. In order to define the actual values of hardness increase at the rail running surface, the Ministry of Transport conducted, in consultation with ZET Ltd., hardness testing of HH rails type Ri-60 (steel grade 900A) at the tram track in curve. Measurements were made just before the track was put to regular use, and also one month later, i.e. after it was subjected to 0.5 million gross tones load. Measurements were made at six sections on the running surface of the outer and inner rail of the curve. Results showed that after a month of use, hardness values on the rail running surface increases, on an average, for 39 HBS (13 %) due to cold forging (Figure 9). As expected, the greater increase in hardness occurs at outer rail as it is more exposed to load. The results of this investigation lead to the conclusion that, if the rails had been in operation, the process of cold forging would have caused such an increase in the running surface hardness that would be compliant with the required minimum values.

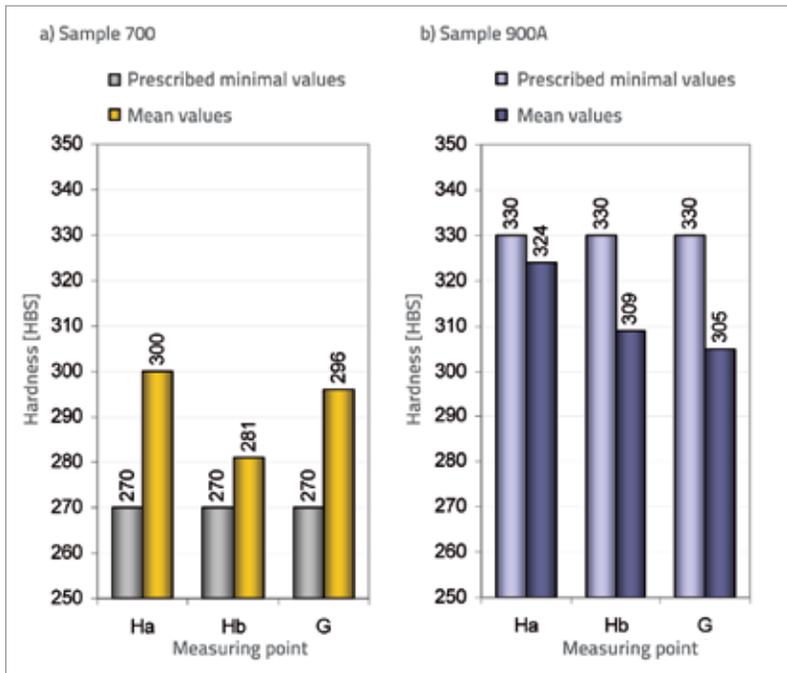
Figure 7. Mean hardness values calculated at the running surface: a) samples 700-1 and 700-2; b) samples 900A-1 and 900A-2

An overview of the mean hardness values, based on values measured at the running surface of the rail head and the guide, is given in Figure 7. In case of samples 900A, none of the mean values met the prescribed requirements (Figure 8). However, this unduly low hardness values at running surfaces have been neglected, as measurements were performed on rail samples that were not in service and therefore their running surfaces were not subjected to cold forging.

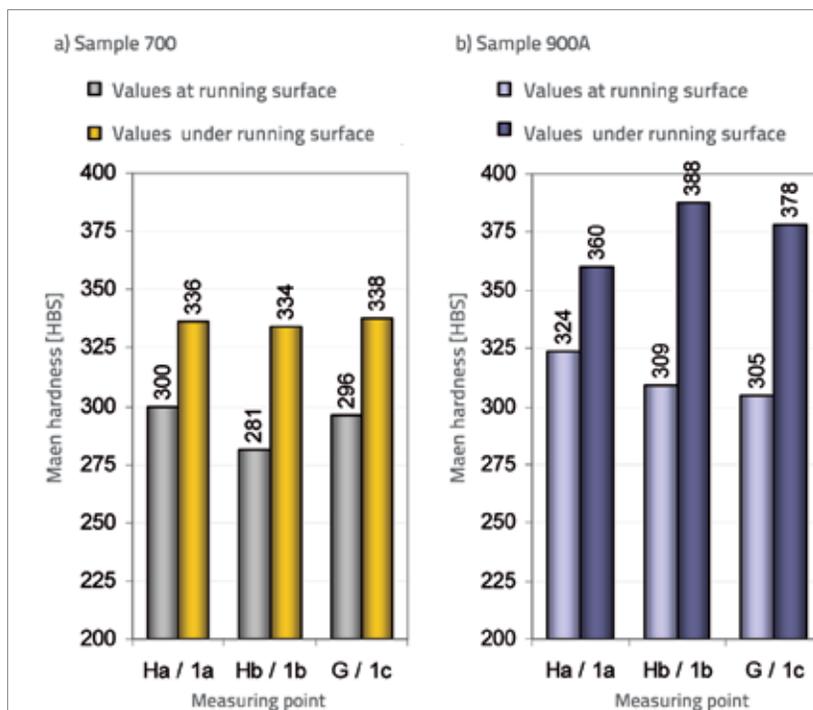
Figure 10. Comparison of mean hardness values at the running surface and 10 mm under the running surface: a) samples 700-1 and 700-2; b) samples 900A-1 and 900A-2

The comparison of the mean hardness values at the running surface of the rails, and at measurement points 10 mm below the running surface, is shown in Figure 10. Mean hardness values 10 mm under the running surface are far greater than the mean hardness values at the running surface. Differences between these mean hardness values, and an increase of hardness under the running surface, are shown in Figure 11 for each sample. The analysis of results showed that the hardness values measured 10 mm under the surface are, on an average,

higher by 22 % (samples 700) and 25% (samples 900A) when compared to hardness values on the running surface. Due to large variation in hardness values across a very small area of cross section (with the depth of only 10 mm), a new set of measurements was made in order to define the actual distribution of hardness values across the entire cross-section of rail samples.

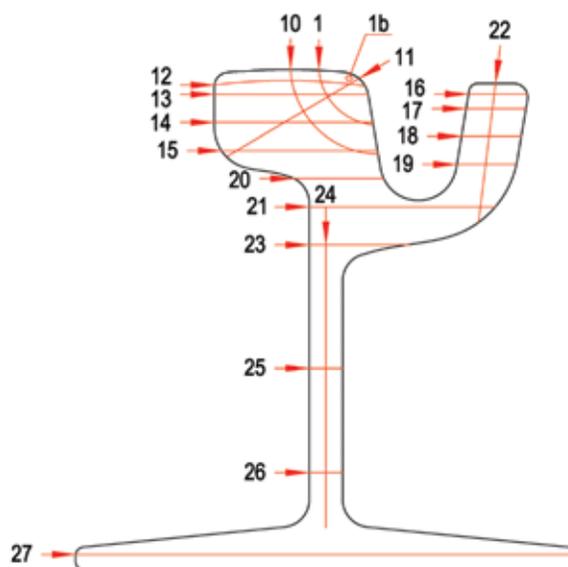
Figure 12. Hardness measurement lines at the rail cross-section

Hardness measurements were conducted at 285 measurement points along 20 measurement lines (Figure 12) of each sample. In order to define the mean hardness value for each measurement line, the total of 1140 individual hardness values were analysed. The calculated mean hardness values are shown in Figure 13. Variations of mean hardness values across the entire cross-section can be observed. An another common observation is that they are all greater than the prescribed minimum hardness value for a particular type (quality) of rail steel and the location of the measurement line in the cross-section of the rail head. A detailed analysis has shown that mean hardness values are on an average by 27 % (sample 700) and 26 % (sample 900A) higher than the minimum prescribed. Differences between samples 1 and 2 of the same rail steel quality (expressed as percentage) are shown in Figure 14. It is evident that differences are greater for samples 900A than for samples 700. The difference in mean hardness values along the measurement line 14 for samples 900A is as high as 25%. In case of samples 700, the biggest difference was observed along the line 20 (15%). The mean difference in hardness values between samples 900A-1 and 900A-2 is 10 %, while the mean difference between samples 700-1 and 700-2 is 5 %.

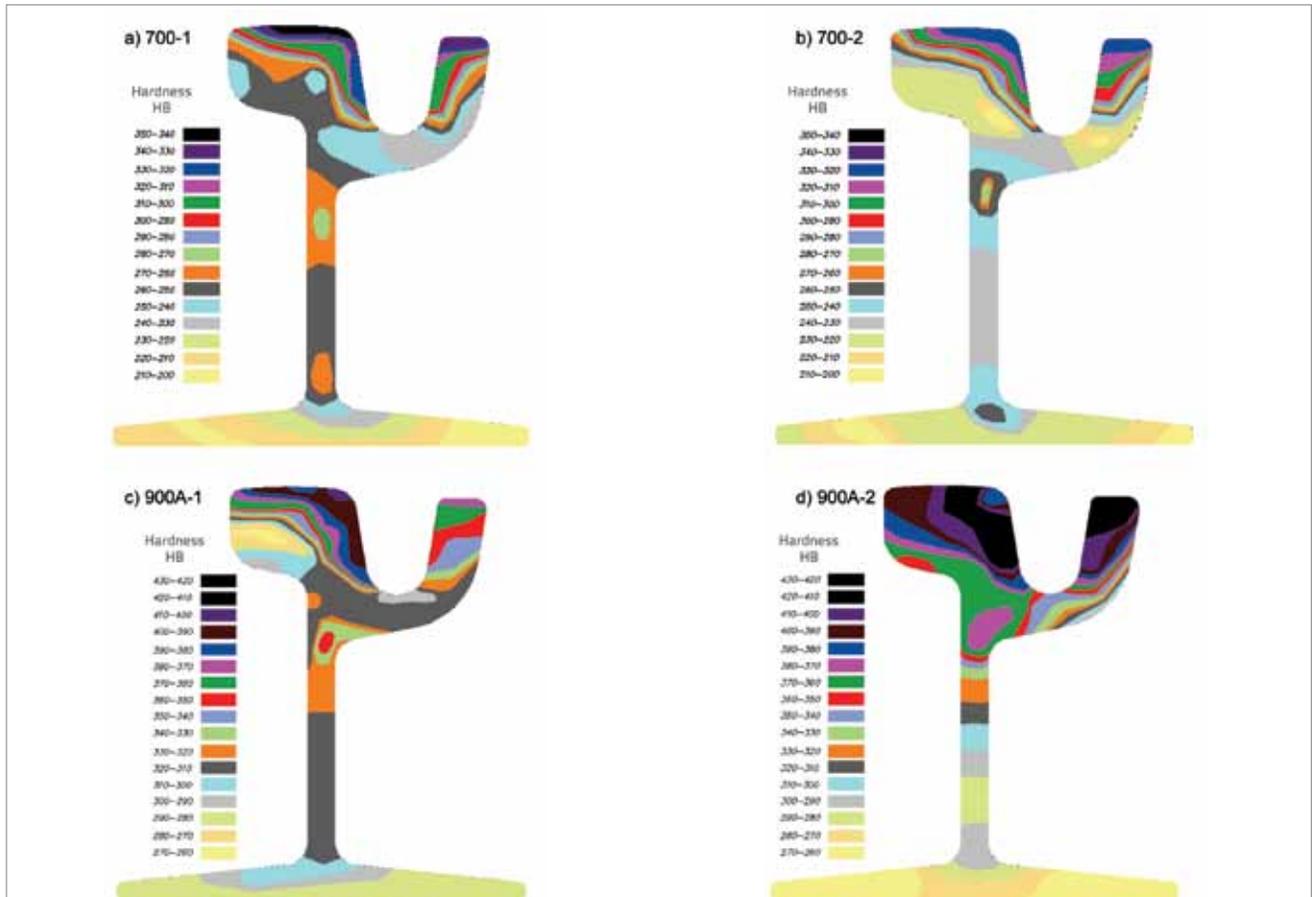
Figure 15. Hardness as a function of location in the rail cross-section: a) sample 700-1; b) sample 700-2; c) sample 900A-1; d) sample 900A-2

Graphic representations of the variation of hardness values across the cross-section (Figures 15 and 16) were made

based on mean hardness values calculated along individual measurement lines. It can be seen from these figures that there is an extremely non-uniform distribution of hardness values across the rail cross-section. The values gradually decrease from the running surface, thru the rail head, to the web and rail base. Also, local areas of increased hardness values at the head-web and web-base transitions are clearly visible.

Hardness tests carried out at the cross-section of HH rails made of steel grade 700 and 900A, as described in this paper, point to extremely uneven distribution of hardness values along the cross section. The impact of such large hardness value deviations on the rail behaviour in track is unknown. It is assumed that this phenomenon may be associated either with conditions during production – rolling of steel rails, or with segregation and/or deformation of steel during its hardening [13]. Deficiencies in the process of rail head heat treatment, conducted in order to increase local hardness values, may also be responsible for inconsistent values of mechanical properties of steel along the rail head cross-section (hardness, and hence tensile strength). In general, any heat treatment leads to changes in steel microstructure. The difference in the warming and cooling (quenching) process, and the uneven distribution of temperature in different layers of the rail head (in cross section and along the rails), cause substantial variations in microstructure, which in turn results in local hardness and tensile strength differences. Experience has shown that such irregularities in the HH rail production process can cause very adverse martensitic microstructure in the heat-treated steel layer [14], which is responsible for the increase in brittleness and decrease in fracture toughness of rail steel attaining up to 25 % [15].

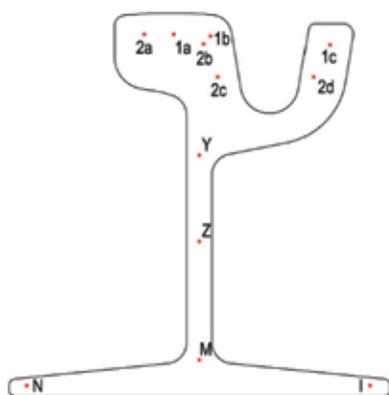
Figure 16. Hardness measurement points

All measurement points at which hardness tests were conducted in order to define the tensile strength of rail steel are shown in Figure 16. In addition to previously defined measurement points 1 and 2 at the rail head cross-section, measurements were also conducted at five points located along the web and the base of the rails. These additional points were selected on the basis of graphic variation of hardness values (Figure 15) at which significant change in the hardness of steel occurred.

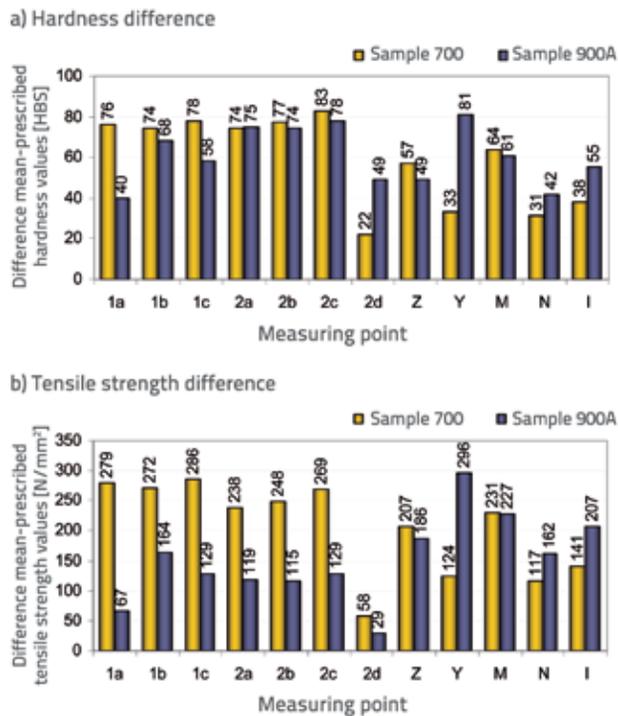
Figure 17. Difference between calculated mean values and prescribed minimum values of hardness and tensile strength

Comparison of prescribed minimum and mean values calculated for each section of the cross-section has shown that the mean values are by an average of 26 % (samples 700) and 22 % (samples 900A) higher than the prescribed ones. The results of mean tensile strength values calculated in cross-sections were satisfactory despite the great variability of hardness values.

Hardness values measured across the rail cross-section are much larger (24 % on an average) than the prescribed minimum, which leads to the conclusion that the cause of their poor in-service behaviour is not due to low hardness and tensile strength values of their steel.
