Hardness distribution over cross-section of grooved rails

Stjepan Lakušić, Maja Ahac

Head hardened rails have been introduced in order to extend the rail-replacement cycles for Zagreb tram tracks. During their precurving, the rail cracking occurred. Hardness tests were performed and tensile strength was calculated to establish whether unusual mechanical properties of rail steel are responsible for the cracking. Tests have shown that hardness values, despite significant variation over the rail cross-section, are higher than the prescribed minimum. It is assumed that rail problems encountered may be due to changes in rail steel microstructure resulting from an increase in rail head hardness during its thermal treatment.

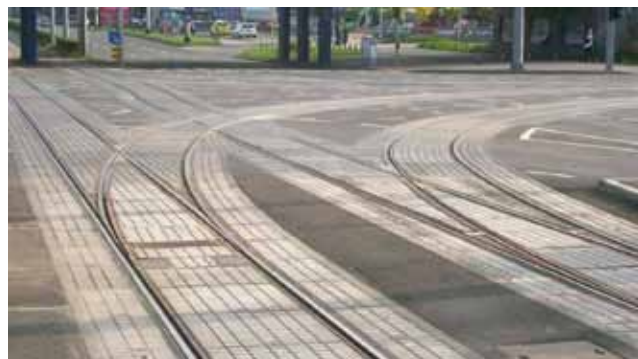
Figure 1. Standard tram track structure in Zagreb

Due to high vertical and/or gauge face rail head wear rate, tracks subjected to very high traffic load, such as the tram tracks in Zagreb (individual tram lines in the city centre are exposed to traffic of 15 million gross tons a year, with the tram vehicle passing frequency of under one minute [3]), and also tracks with high share of small radius curves ($R_{min} \geq 18m$), often call for premature rail replacement. Rail replacement at places where tram corridor is also used by other traffic (Fig.1) represents the biggest maintenance issue for the Zagreb Municipal Transit System – ZET Ltd. At these

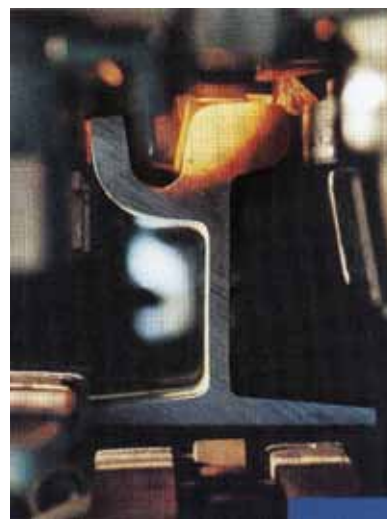
Figure 2. Heat treatment of the grooved rail head [5]

locations, where tram tracks are embedded either in asphalt or in precast concrete plates [4], the organisation of track reconstruction while ensuring an undisturbed operation of other traffic is very complicated if not impossible. In order to extend the rail replacement cycles for Zagreb tram track structures, head hardened (HH) rails have been introduced. There are two main methods of HH rail production: by making modifications in chemical composition of the standard carbon rail steel, or by heat treatment of the rail head (Figure 2. [5]). Foreign experience in the HH rail use shows that increase in rail steel hardness at the wheel-rail contact is a highly efficient and cost-effective method for extending the rail life cycle, because the wear resistance of rails is in that case increased by as many as three times [6]. This positive experience in HH rail use was severely compromised after the ZET Ltd. purchased heat treated HH Ri-60 rails, steel grade 700 and 900A, for which the qualifying test results, provided by the manufacturer, showed satisfactory values of rail steel mechanical properties. First problems occurred during rail precuring (rails were cracking). Rails that were installed in the tracks soon showed significant signs of wear. According to agreement with ZET Ltd., the Ministry of Transport conducted its own tests in order to

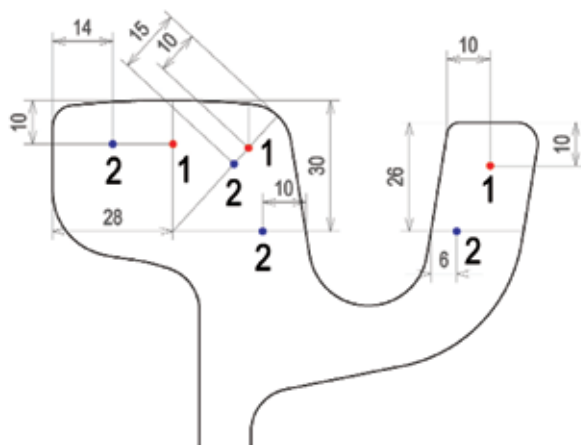
Figure 3. Positions of hardness measurements in the head hardened rail cross section [9]

In case of HH rails, mechanical properties of steel at rail web and base must comply with prescribed values for the basic steel grade given in Table 1 [7, 8], while the steel in the head area (Figure 3) must meet additional requirements shown in Table 2 [9].

Hardness measurements were conducted at measurement points 1 and 2 of the rail head defined by [9], at three additional points at the running surface (marked as Ha and Hb), and at the rail guide (G) (Figure 3 and 4). Measurement points marked as 1a, 1b, and 1c are located 10 mm below the running surface, which is the zone of maximum tangential stresses in the rail cross-section. The measurement point 2a location corresponds to the location of sampling for the tensile strength testing. In total, more than a hundred hardness measurements were carried out at these measurement points.

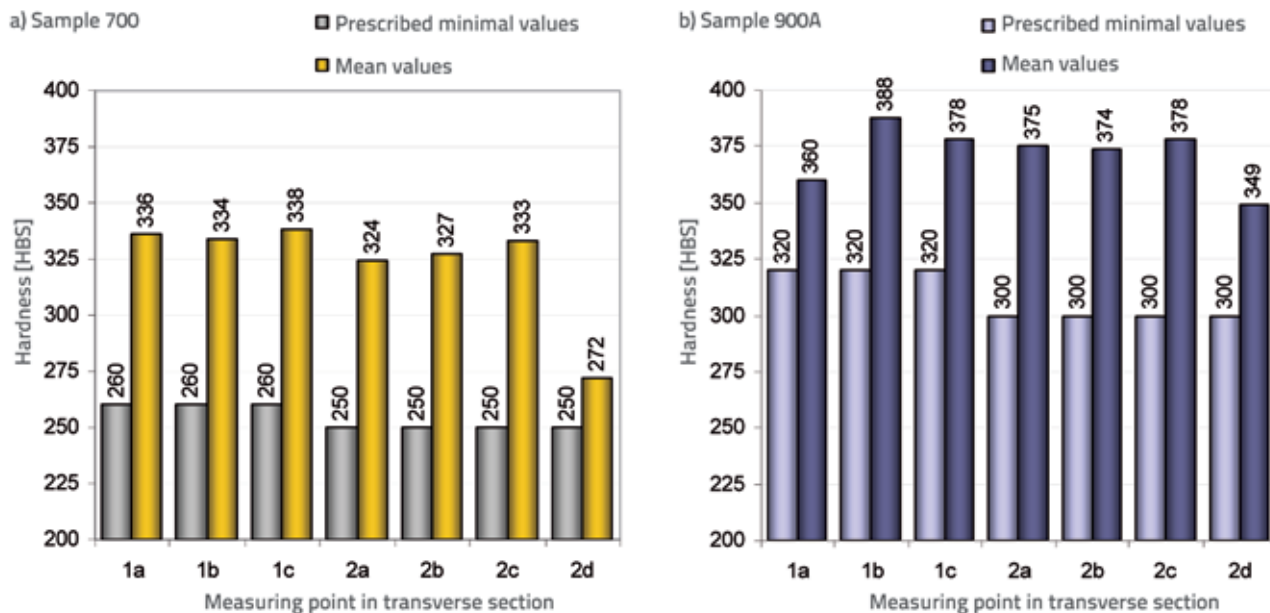
Figure 5. Mean hardness values at the rail head cross-section: a) samples 700-1 and 700-2; b) samples 900A-1 and 900A-2

An overview of mean hardness values, calculated on the basis of values measured at the points 1 and 2, as related to prescribed minimum values given in Table 2, is given in Figure 5. The difference between the mean and prescribed minimum hardness values for each measurement point, expressed as percentage, is given in Figure 6. It can be seen that all mean hardness values are greater than prescribed minimum values, with an average 25 % increase in hardness. The biggest difference in all four cases was observed at the measurement point 2c, where mean hardness values exceed the prescribed minimum by 33 % (samples 700) or 26 % (samples 900A).

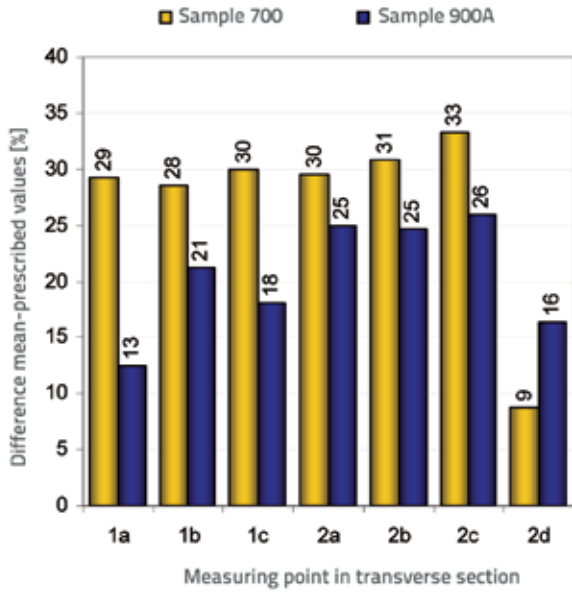
Figure 6. Difference between the mean and prescribed minimum hardness values at the rail head cross-section

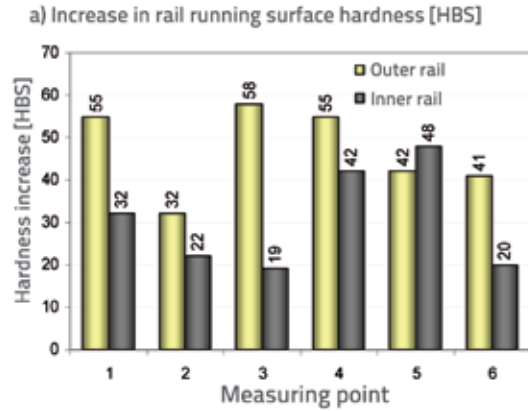
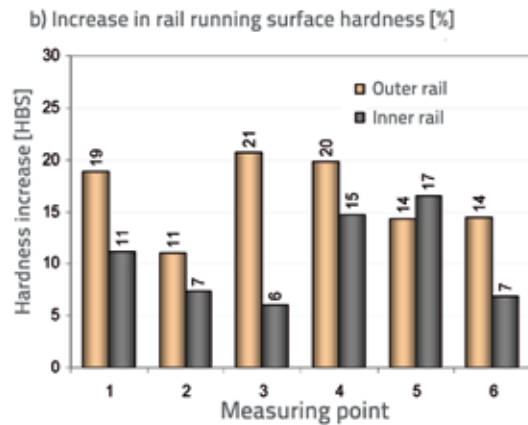
Figure 9. Increase in the rail running surface hardness due to cold forging

Cold forging induces hardening of the rail running surface due to continuous passing of vehicle wheels. The increase in hardness values depends on the magnitude of the total travel load, axle load, rail steel quality, wheel radius, etc. In order to define the actual values of hardness increase at the rail running surface, the Ministry of Transport conducted, in consultation with ZET Ltd., hardness testing of HH rails type Ri-60 (steel grade 900A) at the tram track in curve. Measurements were made just before the track was put to regular use, and also one month later, i.e. after it was subjected to 0.5 million gross tones load. Measurements were made at six sections on the running surface of the outer and inner rail of the curve. Results showed that after a month of use, hardness values on the rail running surface increases, on an average, for 39 HBS (13 %) due to cold forging (Figure 9). As expected, the greater increase in hardness occurs at outer rail as it is more exposed to load. The results of this investigation lead to the conclusion that, if the rails had been in operation, the process of cold forging would have caused such an increase in the running surface hardness that would be compliant with the required minimum values.

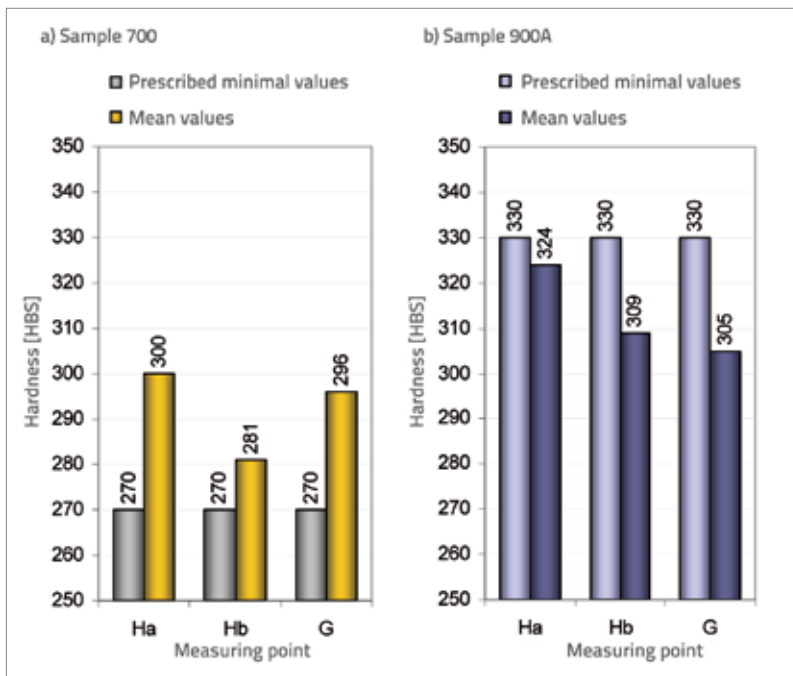
Figure 7. Mean hardness values calculated at the running surface: a) samples 700-1 and 700-2; b) samples 900A-1 and 900A-2

An overview of the mean hardness values, based on values measured at the running surface of the rail head and the guide, is given in Figure 7. In case of samples 900A, none of the mean values met the prescribed requirements (Figure 8). However, this unduly low hardness values at running surfaces have been neglected, as measurements were performed on rail samples that were not in service and therefore their running surfaces were not subjected to cold forging.

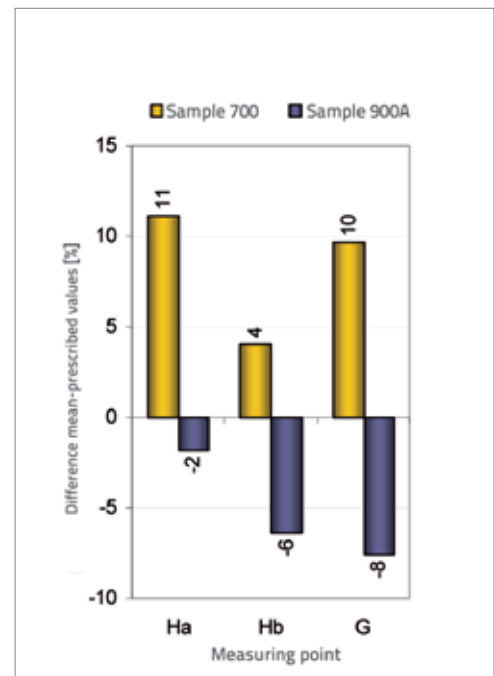
Figure 8. Difference between the mean and prescribed hardness values at the running surface

Test results show that hardness values measured at the running surface of rail head samples 700 are satisfactory, while they are on an average 8% lower than the prescribed values in case of samples 900A. It was concluded that this deviation is negligible since tests were conducted on unused rail samples that were not subjected to cold forging, which is expected to increase the running surface hardness.

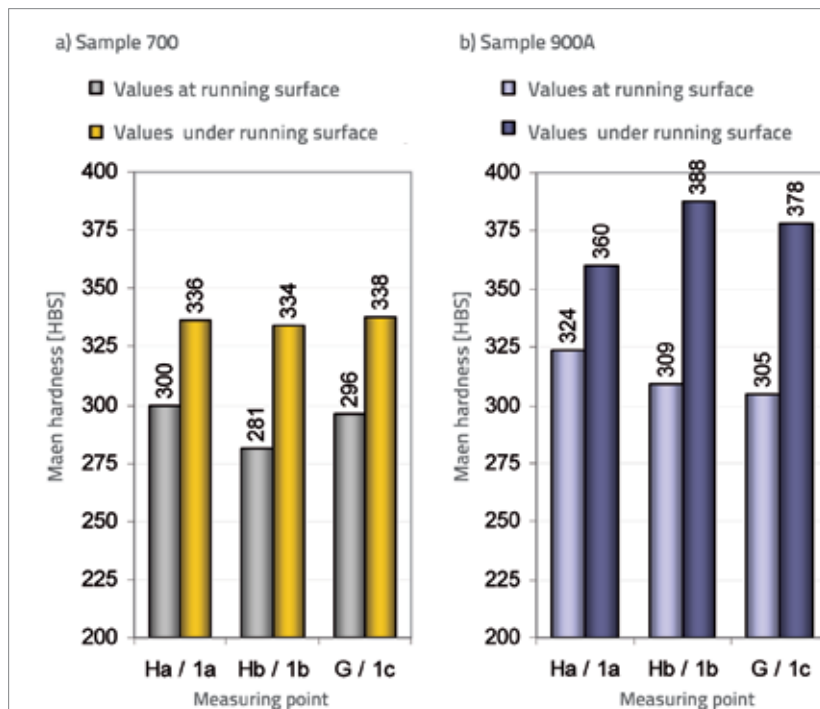
Figure 10. Comparison of mean hardness values at the running surface and 10 mm under the running surface: a) samples 700-1 and 700-2; b) samples 900A-1 and 900A-2

The comparison of the mean hardness values at the running surface of the rails, and at measurement points 10 mm below the running surface, is shown in Figure 10. Mean hardness values 10 mm under the running surface are far greater than the mean hardness values at the running surface. Differences between these mean hardness values, and an increase of hardness under the running surface, are shown in Figure 11 for each sample. The analysis of results showed that the hardness values measured 10 mm under the surface are, on an average,

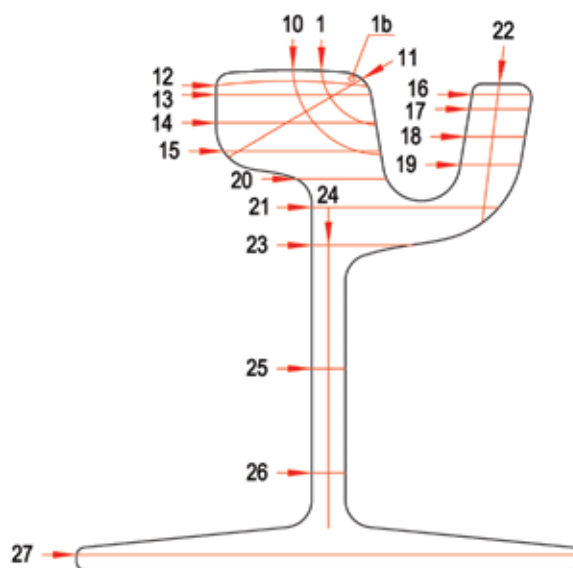
Figure 12. Hardness measurement lines at the rail cross-section

Hardness measurements were conducted at 285 measurement points along 20 measurement lines (Figure 12) of each sample. In order to define the mean hardness value for each measurement line, the total of 1140 individual hardness values were analysed. The calculated mean hardness values are shown in Figure 13. Variations of mean hardness values across the entire cross-section can be observed. An another common observation is that they are all greater than the prescribed minimum hardness value for a particular type (quality) of rail steel and the location of the measurement line in the cross-section of the rail head. A detailed analysis has shown that mean hardness values are on an average by 27% (sample 700) and 26% (sample 900A) higher than the minimum prescribed. Differences between samples 1 and 2 of the same rail steel quality (expressed as percentage) are shown in Figure 14. It is evident that differences are greater for samples 900A than for samples 700. The difference in mean hardness values along the measurement line 14 for samples 900A is as high as 25%. In case of samples 700, the biggest difference was observed along the line 20 (15%). The mean difference in hardness values between samples 900A-1 and 900A-2 is 10%, while the mean difference between samples 700-1 and 700-2 is 5%. Graphic representations of the variation of hardness values across the cross-section (Figures 15 and 16) were made

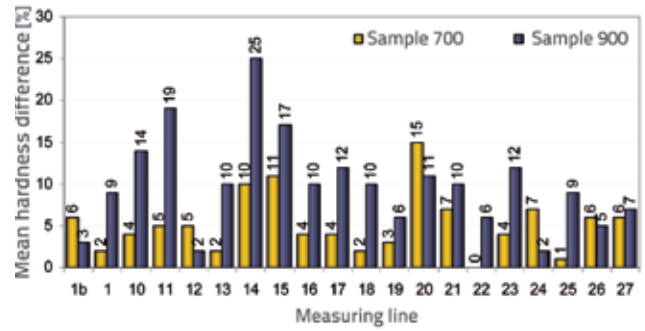
Figure 14. Differences in mean hardness values between samples 1 and 2 of the same rail steel quality

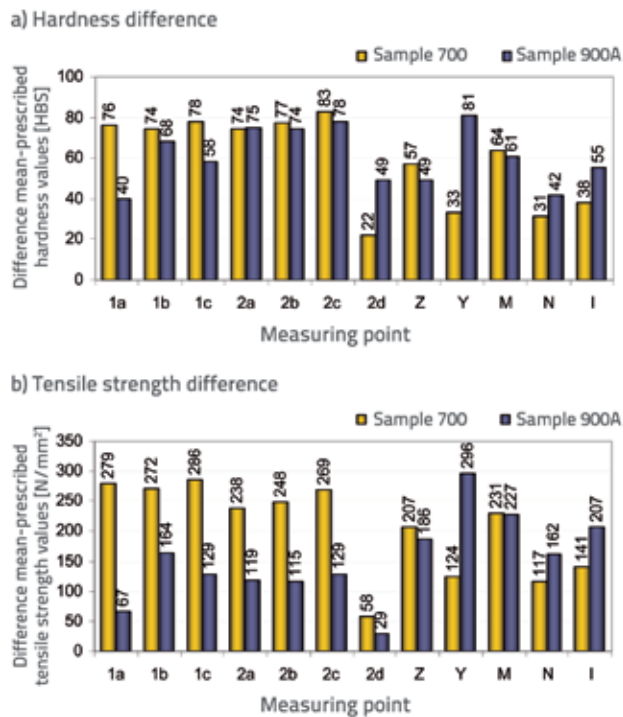
Figure 17. Difference between calculated mean values and prescribed minimum values of hardness and tensile strength

Comparison of prescribed minimum and mean values calculated for each section of the cross-section has shown that the mean values are by an average of 26 % (samples 700) and 22 % (samples 900A) higher than the prescribed ones. The results of mean tensile strength values calculated in cross-sections were satisfactory despite the great variability of hardness values.

Hardness values measured across the rail cross-section are much larger (24 % on an average) than the prescribed minimum, which leads to the conclusion that the cause of their poor in-service behaviour is not due to low hardness and tensile strength values of their steel.
