Behavioural assessment of clock towers subsequently added to historic structures

Assist.Prof. **Burcin S. Seker**, PhD. CE
Amasya University
Merzifon Vocational School
Amasya, Turkey
senol.seker@amasya.edu.tr

Professional paper

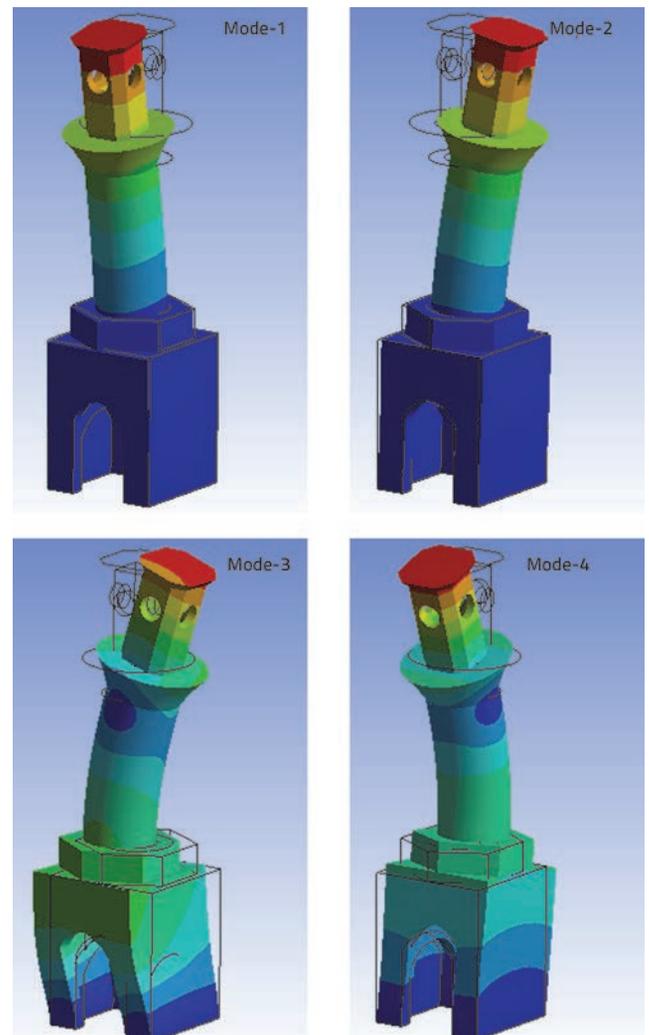
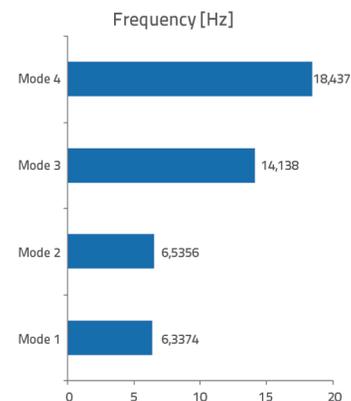
Figure 10. Mode shapes and frequencies of Merzifon Clock Tower

tension at transition areas of these structures. This behaviour can especially be observed at the first mode of Gümüşhacıköy Clock Tower. Therefore, these areas may be expected to deform during an earthquake. Dynamic analysis results suggest that the principal stresses during an earthquake will be concentrated on the junction point of the base of the towers and the entrance gates, while the tower structure that is significantly higher compared to the underlying structure may not keep up with the shift and collapse. Furthermore, a comparison of the results for both towers indicates that Gümüşhacıköy Clock Tower made of wood has caused less damage to the underlying structure. Thus, if it is absolutely necessary to add a structure, then a less solid material should be preferred. The analysis results suggest that tension will increase on the base corner points of the entrance gates of the structures as a result of the shift movement during an earthquake, and that recurring earthquakes will adversely affect these bearing points. Regardless of their purpose, structures subsequently added onto the existing ones are believed to cause serious damages to the existing structures.
