Structural renovation of residential building in Zagreb after the 22 March 2020 earthquake

Professional paper

Juraj Pojatina, Dunja Barić, David Anđić, Dubravka Bjegović

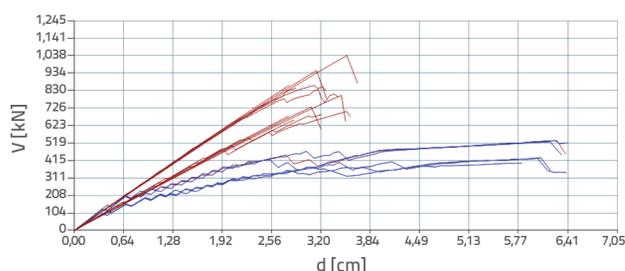
When all capacity curves are shown on the same diagram (Figure 12), it can clearly be seen that the structure has up to two times greater deformation capacity in direction X compared to direction Y. This is due to the fact that shear walls with smaller openings are dominant in direction Y, while large and numerous openings dominate in direction X so that such walls behave more like frames and are primarily resistant to bending action. The ultimate bearing capacity with respect to transverse forces amounts to 534 kN for direction X, while it amounts to 1038 kN for direction Y. As in the pushover

method the deformation of the structure is more important than the ultimate bearing capacity, it can be concluded that the structure exhibits greater resistance in direction X, as can also be seen in Table 2 where the factor of fulfilment values are greater in the analyses in which seismic force is assigned in direction X as compared to the analyses in direction Y. The smallest compliance factor value was obtained in the analysis No. 23 and it amounts to 0.196. This means that the structure can withstand 19.6 % of the design peak acceleration of soil for the return period of 475 years. The diagram with all capacity curves is shown in Figure 12. In this diagram, axis x denotes displacement of the structure, while axis y denotes transverse force in plan view.

Figure 12. Capacity curves for both directions of seismic forces (blue colour denote direction X, while red colour denotes direction Y)

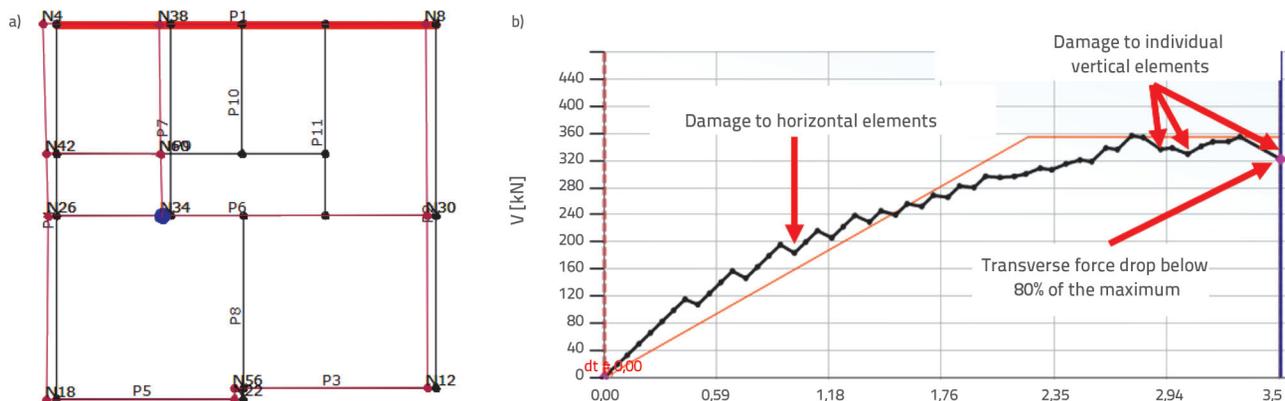
Figure 13. a) Plan view of load bearing walls with deformation line; b) capacity curve of the building for analysis No. 15

The west facade wall is considered as a separate wall in the scope of reference analysis for direction X (analysis No. 15).

Figure 13 shows plan view on which the wall considered in the analysis is marked. The same figure also shows the capacity curve for the entire building, as obtained in the scope of analysis No. 15. At the beginning of the analysis, the response of the structure is approximately elastic with zig-zag line that is typical for all masonry structures. The curve starts to flatten with and increase in displacement or deformation, and the behaviour of the structure becomes non-linear. The damage to elements causes greater

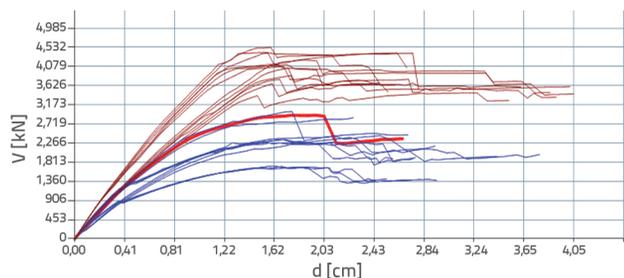
The representation of all capacity curves on a single diagram (Figure 15) reveals that the structure has approximately the same deformation capacity in both directions. The limit resistance to shear load is 3132 kN for direction X, while it is 4450 kN for direction Y. The data given in Table 4 and capacity curves shown in Figure 15 reveal that structural interventions have greatly contributed to an increase in structural resistance in both directions, especially in direction Y, where the deformation capacity of the structure has increased by at least two times. The minimum compliance factor value is the one from the analysis No. 16 and it amounts to 0.768. This means that the structure is capable of withstanding 76.8 % of the design peak acceleration of soil for the return period of 475 years. A diagram of all capacity curves is shown in Figure 15 where axis x denotes the displacement of the structure, while axis y denotes the transverse force in plan view.

Figure 15. Capacity curves for both directions of seismic action (blue colour denotes direction x, and the red colour denotes direction Y)

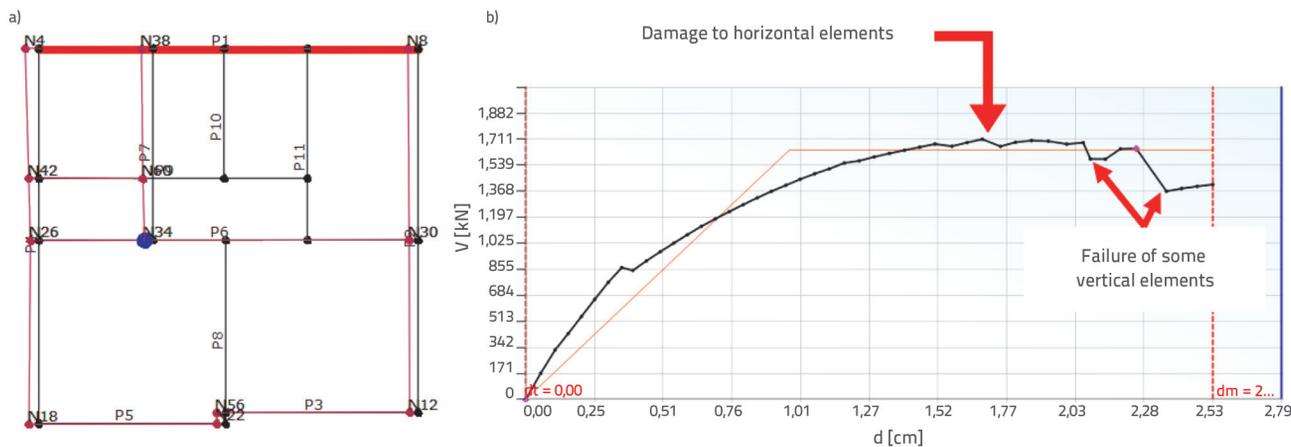
Figure 16. a) Plan view of load bearing walls with deformation line; b) building capacity curve for analysis No. 16

curve for the entire building, given in Figure 16, reveals a much greater period of action in which the structure still behaves in an elastic manner. After the displacement of about 1.7 cm, damage occurs at some elements and the force is redistributed to the remaining elements. The failure finally occurs at the displacement of 2.5 cm.
