# Comprehensive analysis of the damages in Hatay due to the February 2023 Pazarcık and Elbistan earthquakes

Professional paper

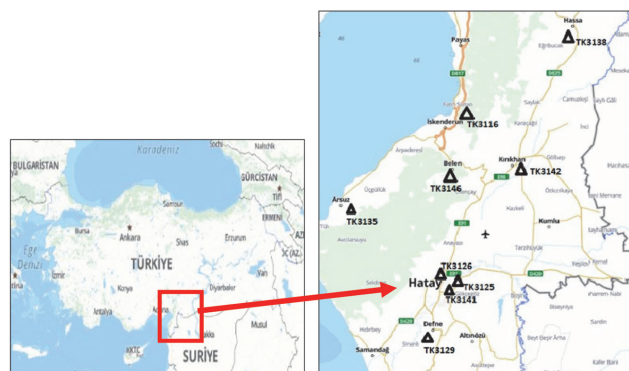
Figure 6. Some accelerometer stations in Hatay during the 6 February Kahramanmaraş earthquakes

motion was recorded in Hatay. Table 1 presents the distances from the earthquake epicentres to the stations in Hatay (Figure 6), the maximum ground acceleration values recorded in each direction at these stations, and the shear wave velocities [13–16]. The spectral curve plots of the 5% damped elastic response spectra at the selected stations were compared with the design spectra specified in the Turkish Building Earthquake Code–2018 [17, 18].

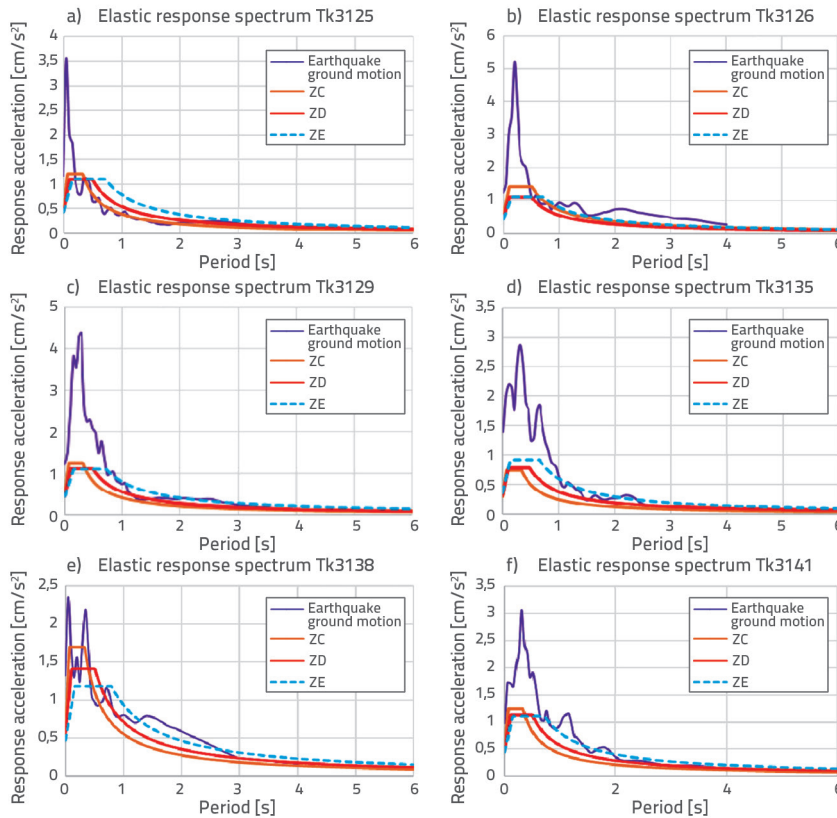
**Figure 7.** Comparison of elastic acceleration spectra of stations Tk3125, Tk3126, Tk3129, Tk3135, Tk3138, and Tk3141 in Hatay with TBEC-2018 design acceleration spectrum graphs

According to the data obtained from stations numbered 3125, 3126, 3129, 3135, 3138, and 3141 in Hatay, which were established by the Turkish Accelerometric Database Analysis System (TADAS) [19] and the Turkey Disaster and Emergency Management Presidency (AFAD) to record earthquakes, horizontal and vertical spectral acceleration values higher than the design values stipulated in TBEC-2018 were obtained during the Pazarcık earthquake (7.7 Mw) at 0–1 s intervals. All three components (east–west, north–south, and up–down) exhibited high spectral acceleration values, which contributed to a high degree of damage in that region. The DD-2 spectrum (representing

an earthquake with a 10% probability of occurrence over 50 years) was lower than the recorded spectral acceleration

values. For example, in the February 2023 earthquakes, the largest acceleration value measured at station 3126 was 1.2 g, whereas the design-level prediction was only 0.41 g. Specifically, the observed acceleration was approximately three times larger than expected value (Figure 7.b).
