Analysis of cracking on running surface of rails

Professional paper

The problem of cracking at the rolling surface of rails is considered in the paper. This damage to the rolling surface of rails, known as "squat", may lead to disintegration of rail head in the length of 1 m or more. In the scope of this research, a detailed visual control of rail damage at the Vrbnica – Bar Section of the Montenegrin railway network was conducted in order to alleviate danger of rolling contact fatigue cracking in rails. Results obtained can be used as basis for preparation of technical regulations for railway track maintenance along the Montenegrin railway network.

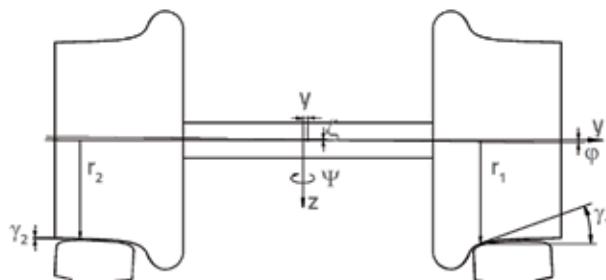
To determine the force acting in the wheel/rail contact zone, the following range of geometrical parameters must be known: position of contact points on the left-side and right-side wheels, position of contact points on the left-side and right-side rails, current radius of circles at contact points (r_1, r_2) and their difference (Δr), equivalent conicity, profile angle at contact points (γ_1, γ_2), radius of wheel profile and rail curvature at contact point, coefficient of contact stress at contact point, angle of axle assembly toward the horizon (φ), and vertical displacement of its centre of gravity (ζ) (Figure 6).

Figure 6. Geometrical parameters for determination of wheel/rail contact forces [15]

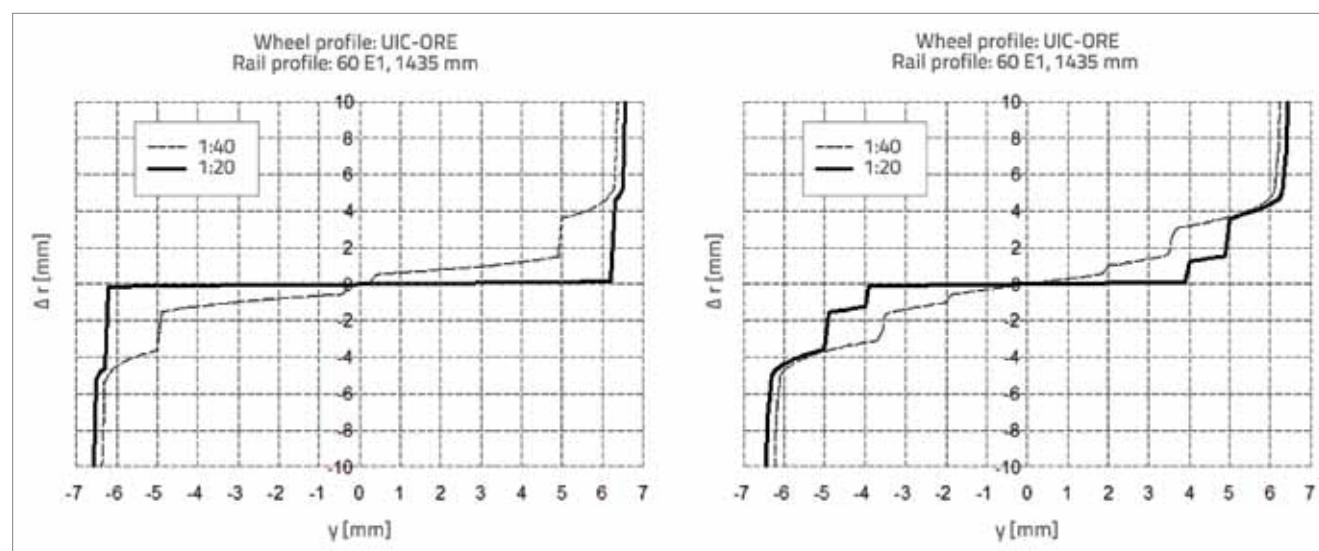
In addition, wheel/rail contact forces depend on: wheel profile and its current geometry, rail profile and its current geometry, rail inclination ($1:20, 1:40, 1:\infty$), current track gauge, and current wheel flange gauge (Figure 7).

Figure 7. The Δr function (difference of current radii at the contact points) [15]

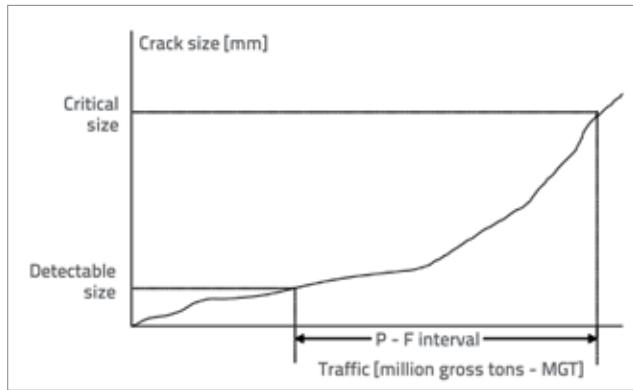
A crack has a certain detectable size (P – crack development potential prior to detection). The effectiveness of crack detection depends on the efficiency and accuracy of inspection equipment. It also depends on the skill and experience of inspectors. From this size the propagation of the crack can be monitored until it attains the critical size, when a rail break

can be expected (F – failure due to breakage). The time or traffic load (expressed in millions of gross tons) between crack detection and rail break can be used to define the P-F interval (Figure 9).

Figure 9. Definition of P-F interval [19]

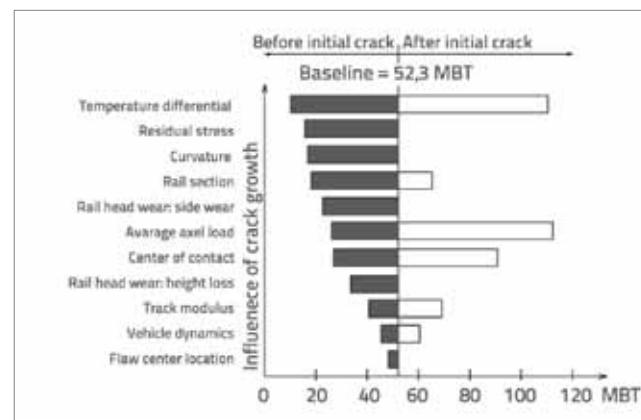
As a part of the project [19], a sensitivity analysis was performed to demonstrate how the crack growth rate is affected by different traffic and track conditions. Figure 3 shows the result of the analysis [19]. Various factors are ranked according to their impact on crack growth over the rail life span.

Figure 10. Influence of various factors on crack growth [19]
